MANDATORY SERVICE BULLETIN

NUMBER: SB-001
REVISION: B
DATE: 06/01/2010

SUBJECT: FLAP SYSTEM, Flap Actuation; Mandatory Inspection Procedures

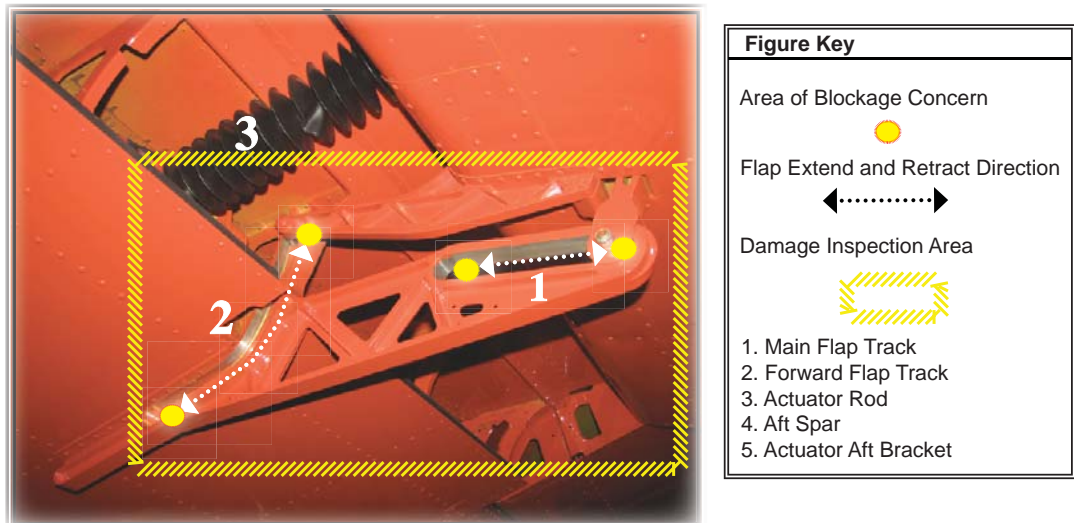
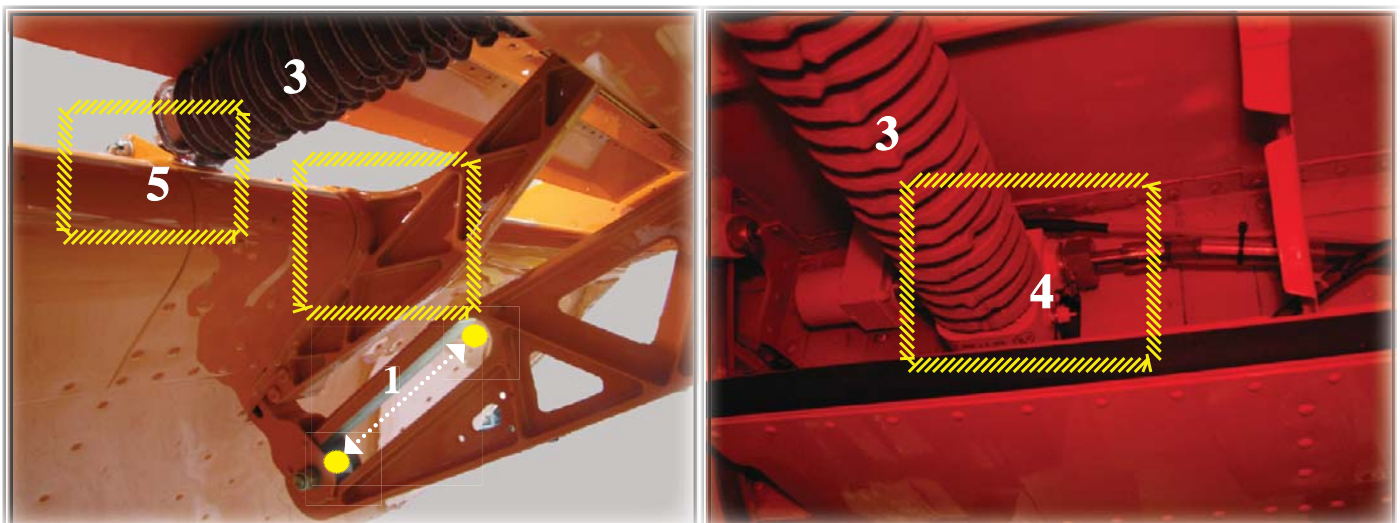
Figure 2: Inspection Areas

The illustrations in this section highlight the visual inspection areas that require special attention.

Pilots must inspect to avoid the potential situation. When operating in temperatures below +5° C (+41° F), pilots must ensure that all debris are removed from the main flap tracks. During cold weather operations, if the aircraft takes off in snow or slush, visually check the main flap tracks for any debris build-up that may have occurred. If build-up has formed after takeoff or in-flight, **DO NOT** operate the flaps. Follow the guidance listed in the KODIAK 100 Pilot Operating Handbook/Aircraft Flight Manual to perform a 0° flap landing. If the flap tracks became blocked during takeoff, leave the flaps in the takeoff setting (normally 20°) and return to the airfield. A revision to the Pilots Operating Handbook/Aircraft Flight Manual and abbreviated checklist will be issued in the near future adding flap inspection procedures. Use the procedures below to perform the inspection.

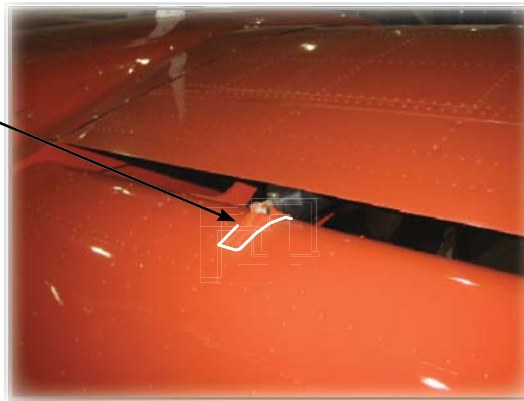
Figure 3: Upper Flap Surface

During the Exterior Preflight Inspection, visually check the forward and main flap tracks (12 total) to ensure that debris has not become lodged in the track and that there was no damage to the flaps during the previous flights. In addition, inspect the upper and lower wing surfaces for signs of debris build-up. See **Figure 3**.

Upper Wing and Flap Surface
(Flap Connection Point Outlined in White)
