**\*MANDATORY SERVICE BULLETIN\*****NUMBER:** SB11-15**REVISION:** 01**DATE:** 10/05/2011**SUBJECT:** CREW SEAT CHAIN PLATE INSPECTION**EFFECTIVITY:**

KODIAK 100 Series Aircraft Serial Numbers: 100-0001 through 100-0054

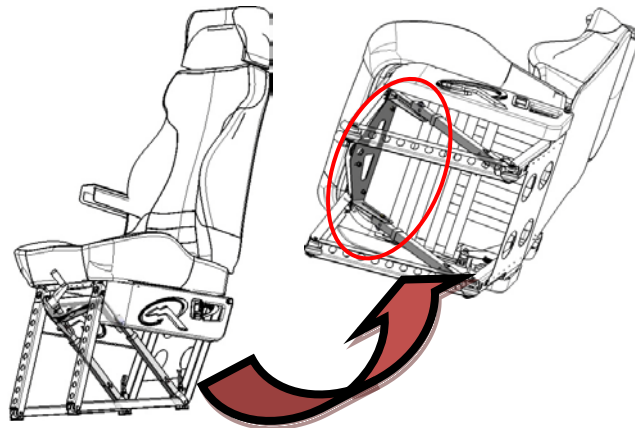
1. Gain access to the bottom of the crew seat.

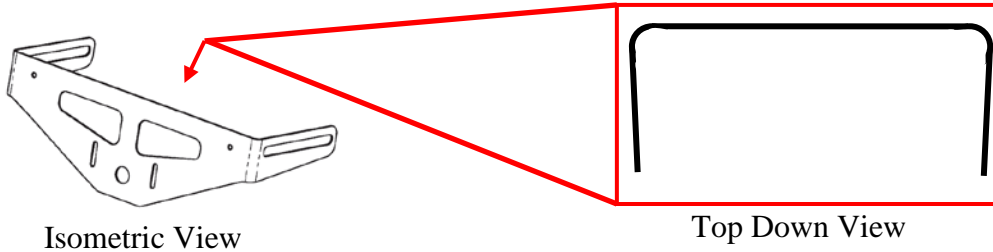
2. Inspect the Crew Seat Chain Plate (P/N 100-825-1231) for:
  - 2.1. Correct shape (See image below).

- 2.3. If brackets are incorrectly bent or cracks are found, the part(s) must be replaced. Contact Quest Aircraft Customer Service to order replacement parts.
  - 2.4. If no damage is found, continue to **Step #3**.
3. Repeat inspection procedure on the other crew seat.
4. Upon completion of all work instructions, record work completed in the appropriate *Kodiak 100 Log Books*.

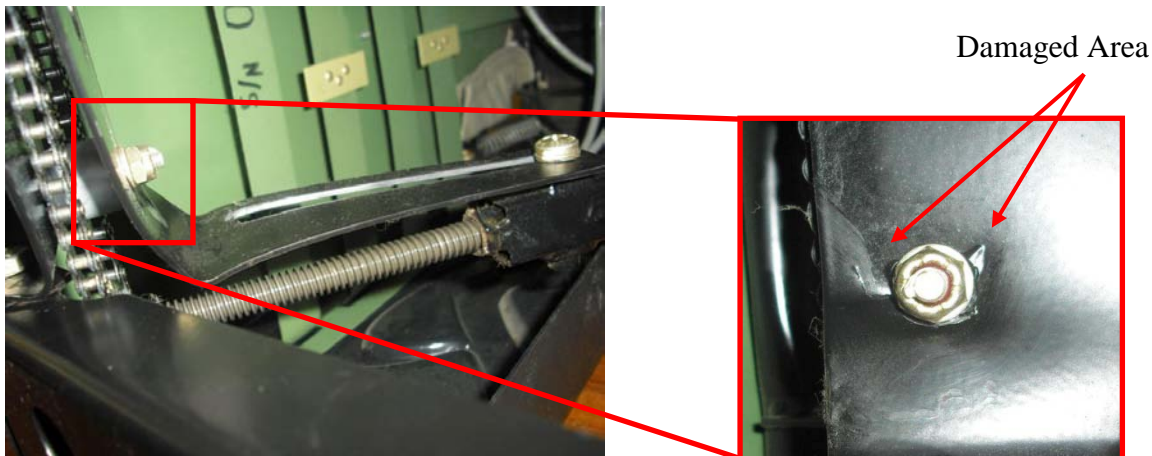
It has been found on one aircraft with over 1,000 flight hours that a crack has started to form around the nut on the crew seat chain plate, as shown on the next page. The damage is caused by users adjusting the seat height beyond its upper limit. (Adjustment arm located on the front of the crew seats between the occupant’s legs.) *Quest Aircraft Company* is mandating a one-time inspection of this bracket to bring special attention to mechanics. This inspection does not change or modify the inspection requirements as defined in the *KODIAK 100 Maintenance Manual, Chapter 5 “Time Limits/Maintenance Checks.”*

- 2.2. Cracking and other deformation/damage (See images below).
