MANDATORY SERVICE BULLETIN

NUMBER: SB11-08
REVISION: 00
DATE: 06/24/2011

SUBJECT: SPAR PASS-THRU HOLE AND TAILCONE MODIFICATION

KODIAK 100 Series Aircraft Serial Numbers: 100-0001 through 100-0045.

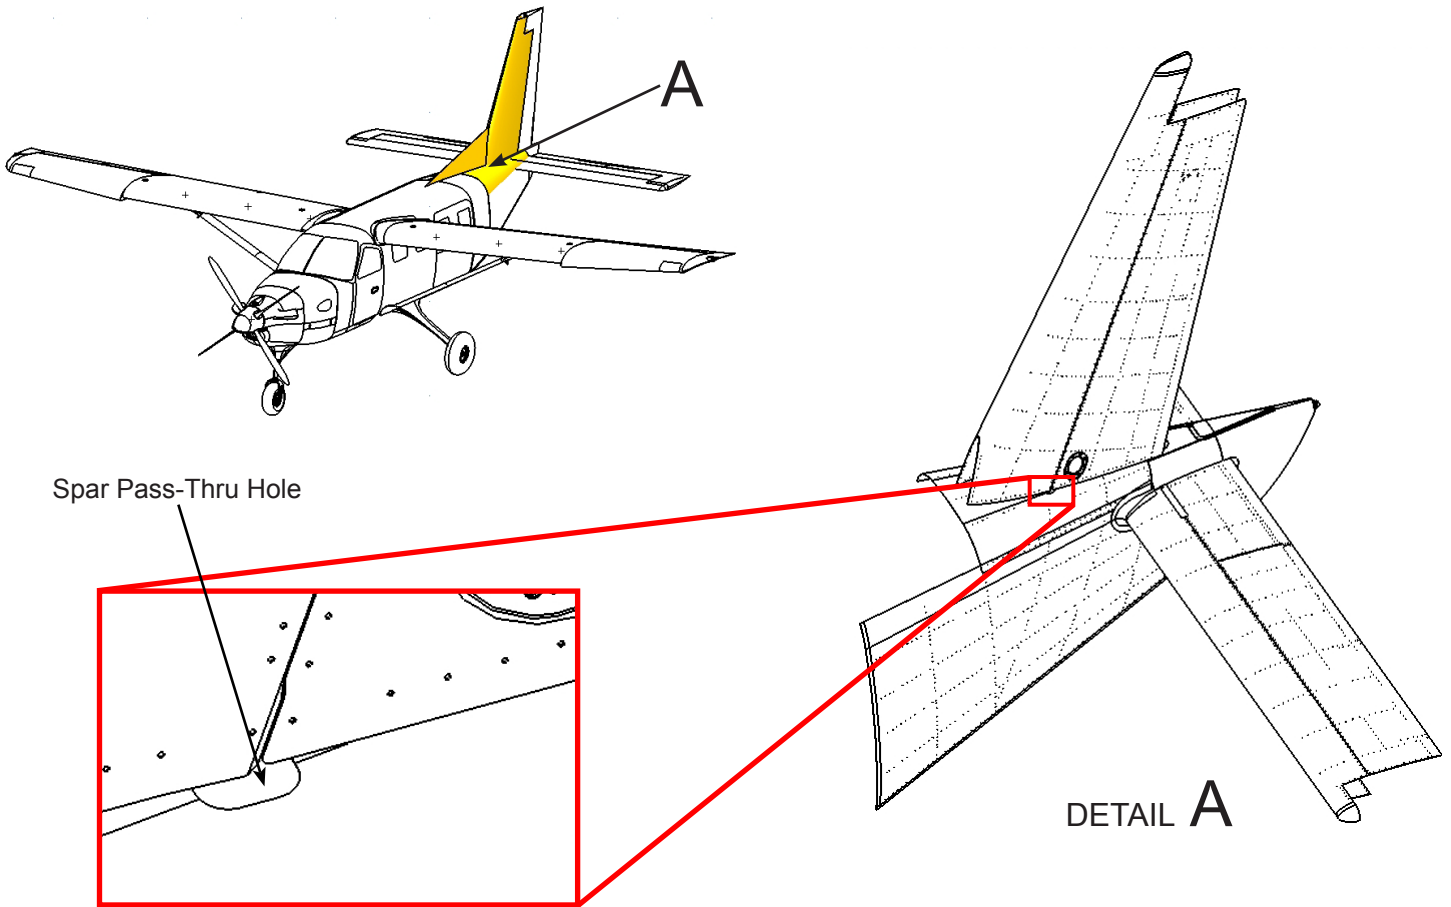
Figure 1-1: Spar Pass-Thru Hole Modification

It has been determined that the mount design of the vertical tail leaves two uncovered areas in the top of the fuselage that allows fluid entry into the area AFT of the rear interior bulkhead. This fluid does not adequately drain, and has a potential to negatively affect some of the electronics.

**NOTE:** Verify that the existing X1010 edge trim on the vertical stabilizer skin is adhered to the skin and in good condition.

Quest is mandating the installation of a sealant over the area indicated in **Figure 1-1**, as well as the installation of two (2) drain grommets on the underside of the tailcone.

1. Apply ProSeal® (P/N **P/S 890 B-2**) into the spar pass-thru holes shown in **Figure 1-1** on both sides of the aircraft. Ensure the sealant adheres around the perimeter of the holes and is faired to the upper surface of the aircraft skin with a 0.06" to 0.13" overlap over the edges of the hole.
2. Follow all manufacture's safety and cure time instructions.
3. Remove the masking tape applied to the inside surface of the aircraft skin.
4. Reinstall the AFT bulkhead into the aircraft as shown in the KODIAK 100 Maintenance Manual (P/N **490770**).
