## SERVICE NOTICE

**SUBJECT:** NOSE GEAR HYPEREXTENSION  
**EFFECTIVITY:** 100-0001 and above

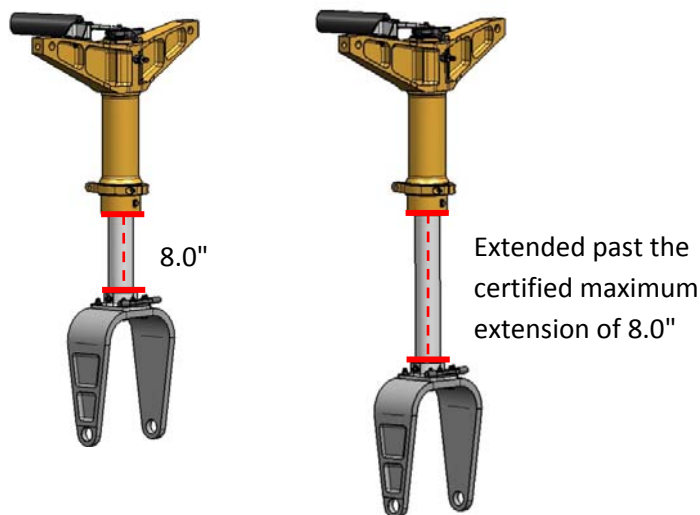
Quest Aircraft has received a single report of the nose gear centering pins failing, which in turn allowed the nose gear to extend past its certified maximum extension of 8.0". This occurred on a plane with approximately 1,563 flight hours; during this time the plane had logged 2,736 landings, the majority of which were on unimproved airstrips. Quest Aircraft does not believe there are any aircraft with an immediate cause for concern; however, if the nose landing gear extends past the certified maximum extension or any of the items listed below are identified, this could indicate a possible issue with the nose landing gear.

1. Loss of direct nose gear steering control
2. Difficulty turning the nose gear
3. Difficulty trimming the airplane in the yaw direction
4. Hyperextension of the piston tube (see figure)
5. Reduced piston tube travel
6. Particulate noted in the nose gear hydraulic fluid

If any of the above items are noticed during operation, maintenance, or disassembly, it is recommended that you contact Quest Aircraft Company immediately with details. Return to service should only be accomplished after discussion with Quest Aircraft and will be dependent upon the detailed findings.
