**\*IMPORTANT SERVICE NOTICE\*****NUMBER:** SN-007 (GARMIN Service Advisory No. 0914 Revision A Attached)**DATE:** 04/23/2012**REVISION:** 01**SUBJECT:** Possible temporary loss of heading/attitude information in Garmin Integrated Flight Deck and G600 Systems following extended power-on stall maneuvers (**Supersedes SL-005**)**SUMMARY**

## SERVICE ADVISORY

NO.: 0933 Revision A

**SUBJECT:** System may select NAV2 as navigation source during approach

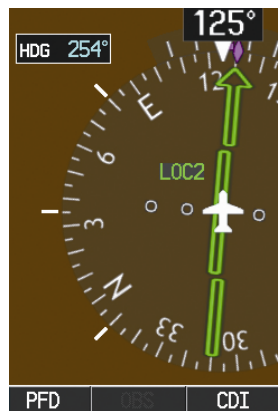
If the CDI Synchronization function is enabled, the system may select NAV2 as the navigation source for the CDI when automatically switching from GPS to LOC during a localizer or ILS approach.

Figure 1. LOC 2 Selected

The pilot may disable the CDI Synchronization function if desired, thus ensuring that the navigation source for PFD1 transitions to LOC1 and PFD2 transitions to LOC2 during a localizer or ILS approach.

Garmin plans to include a change in future software releases that will transition the navigation source for each PFD to the LOC that is associated with the flight-director-selected side, when CDI Synchronization is enabled.
