RECOMMENDED SERVICE BULLETIN

NUMBER: SB13-02

SUBJECT: ELEVATOR DOWN-STOP BUMPER REPLACEMENT

As required for KODIAK 100 Series Aircraft Serial Numbers: 100-0001 through 100-0090.

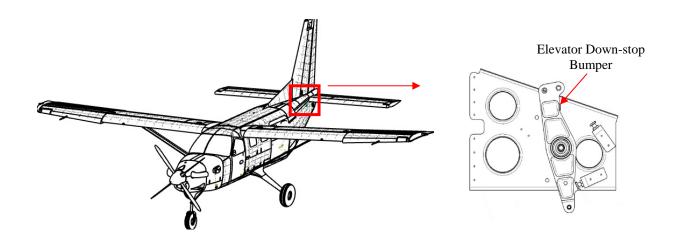
Figure 3-1: Elevator Stop Assembly Overview

Figure 3-1 shows the location of the elevator stop assembly on the KODIAK 100 aircraft.
