MANDATORY SERVICE BULLETIN

NUMBER: SB13-08 REVISION: 00

SUBJECT: VISOR BRACKET

KODIAK® 100 Series Aircraft Serial Numbers: 100-0001 through 100-0085

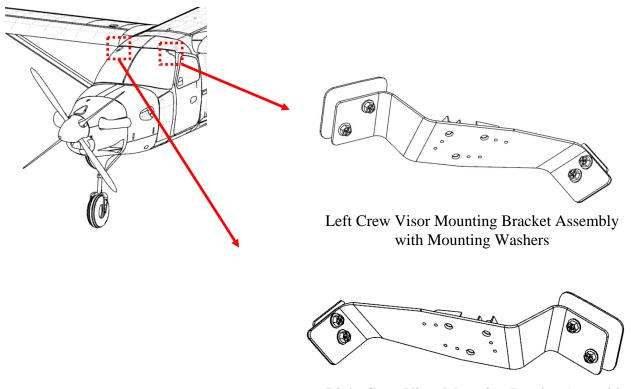
Figure 3-1: Visor Bracket Overview

Right Crew Visor Mounting Bracket Assembly with Mounting Washers
