# \*MANDATORY SERVICE BULLETIN\*

NUMBER: SB13-06 REVISION: 00 **DATE:** June 8, 2013

**SUBJECT: TEN THOUSAND HOUR LIFE EXTENSION FIELD RETROFIT**

KODIAK 100 Series Aircraft Serial Numbers: 100-0001 through 100-0094.

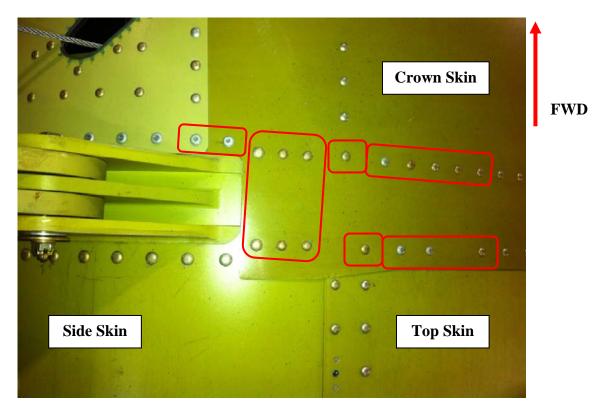
Figure 5-2: Detail View of Figure 5-1 (Left Side) With Fairing Removed

1. Drill out the rivets shown in the **Figure 5-2**.

- 2. Correctly position the shims (P/N 100-935-0917, 100-210-4012, and 100-935-1038) as shown in **Figure 5-2** through **Figure 5-5**, and backdrill to match existing rivet holes.
- 3. Remove and deburr shims.
- 4. Install the shim (P/N 100-935-0917) in the location indicated in **Figure 5-3** and **Figure 5-4** using rivets (P/N CR3213-5). Shim is to fill the skin lap gap between the crown skin and frame.
- 5. Install the shim (P/N 100-210-4012) in the location indicated in **Figure 5-3** using rivets (P/N MS20470AD5) in the two outboard holes, and rivets (P/N MS20470AD4) in the four inboard holes. The shim is to fill the skin lap gap between the crown skin and side skin.

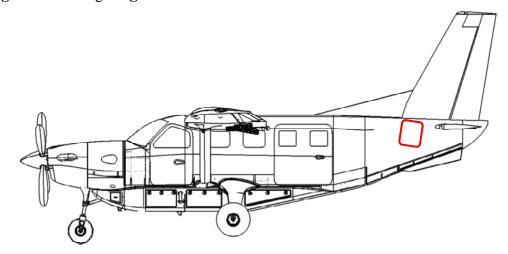
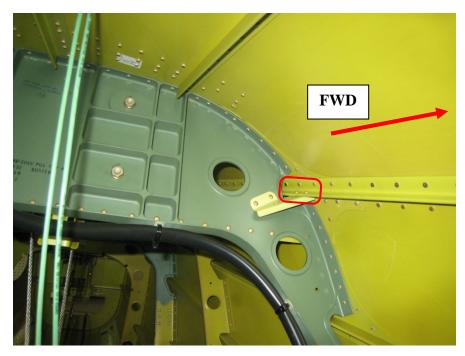
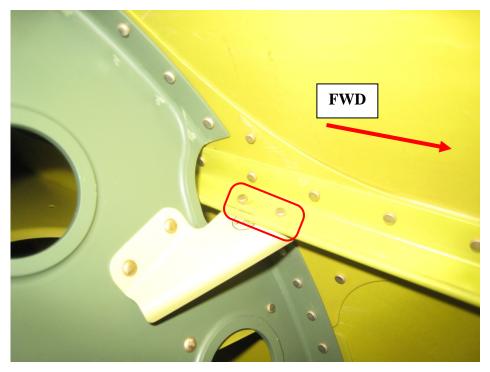
1. Inspect the rivets holding the left and right shear clips to the adjacent stringer, as shown in **Figure 5-7** through **Figure 5-9**.

- 2. If the rivets are MS20470AD4 solid rivets, the installation is acceptable; proceed to **Section 5.3**; if CherryMAX blind rivets are installed, proceed with the following steps:
- 3. Remove the rivets holding each shear clip to the adjacent stringer.

- 4. Up-size each hole to 0.1610'' 0.1640'' using a #24 drill bit and 0.1610'' reamer (#20).
- 5. Inspect each hole to verify a minimum distance of 0.25" from the center of the hole to the edge of the stringer flange.
  - a. If this minimum edge distance is not maintained, contact Quest for further instructions.
- 6. Install Hi-Lok fasteners (P/N HL18PB5-2) and Hi-Lok collars(P/N HL82-5AW) in each hole with the collar facing up.
  - a. If a Hi-Lok collar will not sit flush, install shim (P/N 100-240-2017) using Hi-Lok fasteners (P/N HL18PB5-4) and Hi-Lok collars (P/N HL82-5AW). Clamp the shim in place, nested on the stringer flange under the Hi-Lok collar, such that the fastener hole is centered in the shim, backdrill, and ream to match.

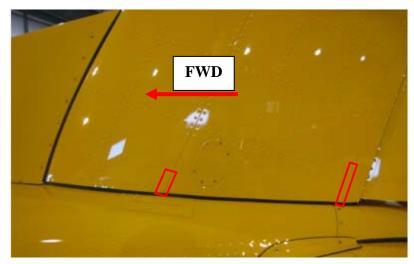
Figure 5-10: Overview of Vertical Stabilizer Rivet Locations

1. Drill out the lower eight (8) forward spar rivets on each side of the aircraft, as shown in **Figure 5-11**.

There are two (2) rows of rivets on each side of the forward spar. The lower four (4) rivets of each row must be replaced (Eight rivets total per side).

- 3. Up-size each hole to 0.159" 0.164" (#21 drill bit) and deburr.
- 4. Install rivets (P/N MS20470AD5).
- 5. Touch up the primer and paint on the aircraft exterior, as needed, in accordance with the  $KODIAK^{®}$  100 Airplane Maintenance Manual, Chapter 12.
- 6. Vacuum the interior of the vertical stabilizer and verify that all rivet debris and shavings have been removed.

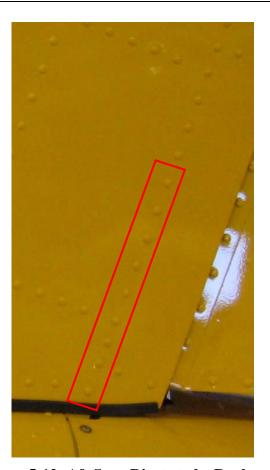
Figure 5-12: Aft Spar Rivets to be Replaced

2. Drill out the lower nine (9) rear spar rivets on each side of the aircraft, as shown in **Figure 5-12**.
