MANDATORY SERVICE BULLETIN**NUMBER:** SB14-10**REVISION:** 00**DATE:** 10/31/2014**SUBJECT:** RUDDER CABLE PASS-THROUGH DOUBLER INSTALLATION**EFFECTIVITY:**

KODIAK® 100 Series Aircraft Serial Numbers: 100-0001 through 100-0135 except with compliance to FSI-097, *Aft Fuselage Skin Doubler Installation*.

Rudder Cable Pass-Through Doubler Installation

FSI-104

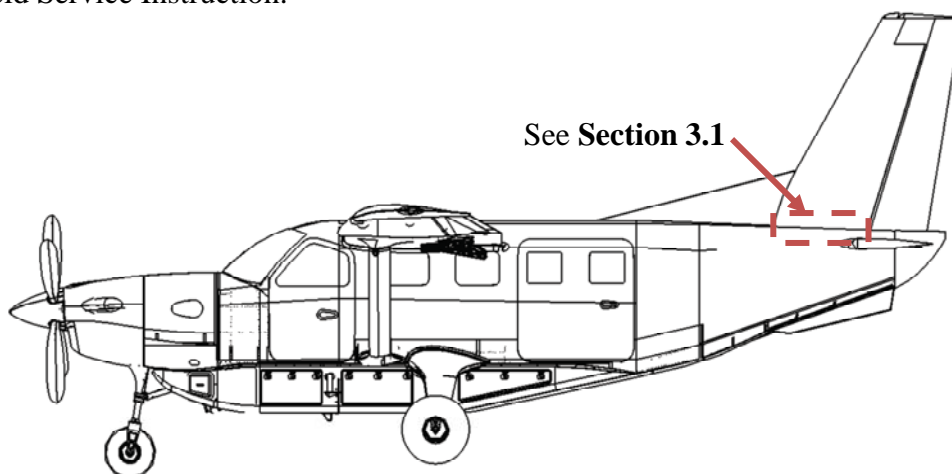
Figure 3-1: Overview

If a crack or other damage is located in the upper aft skin of the fuselage within the region described in **Section 3.1**, then a portion of skin must be trimmed and a doubler installed in accordance with this Field Service Instruction. If cracking is not found, the existing pass-through hole perimeter should be modified and a doubler installed, also in accordance with this Field Service Instruction.

Any damage or cracking found must be completely removed by trimming the section as shown in **Section 5.3**. That trim line matches the inside perimeter of the supplied doublers.

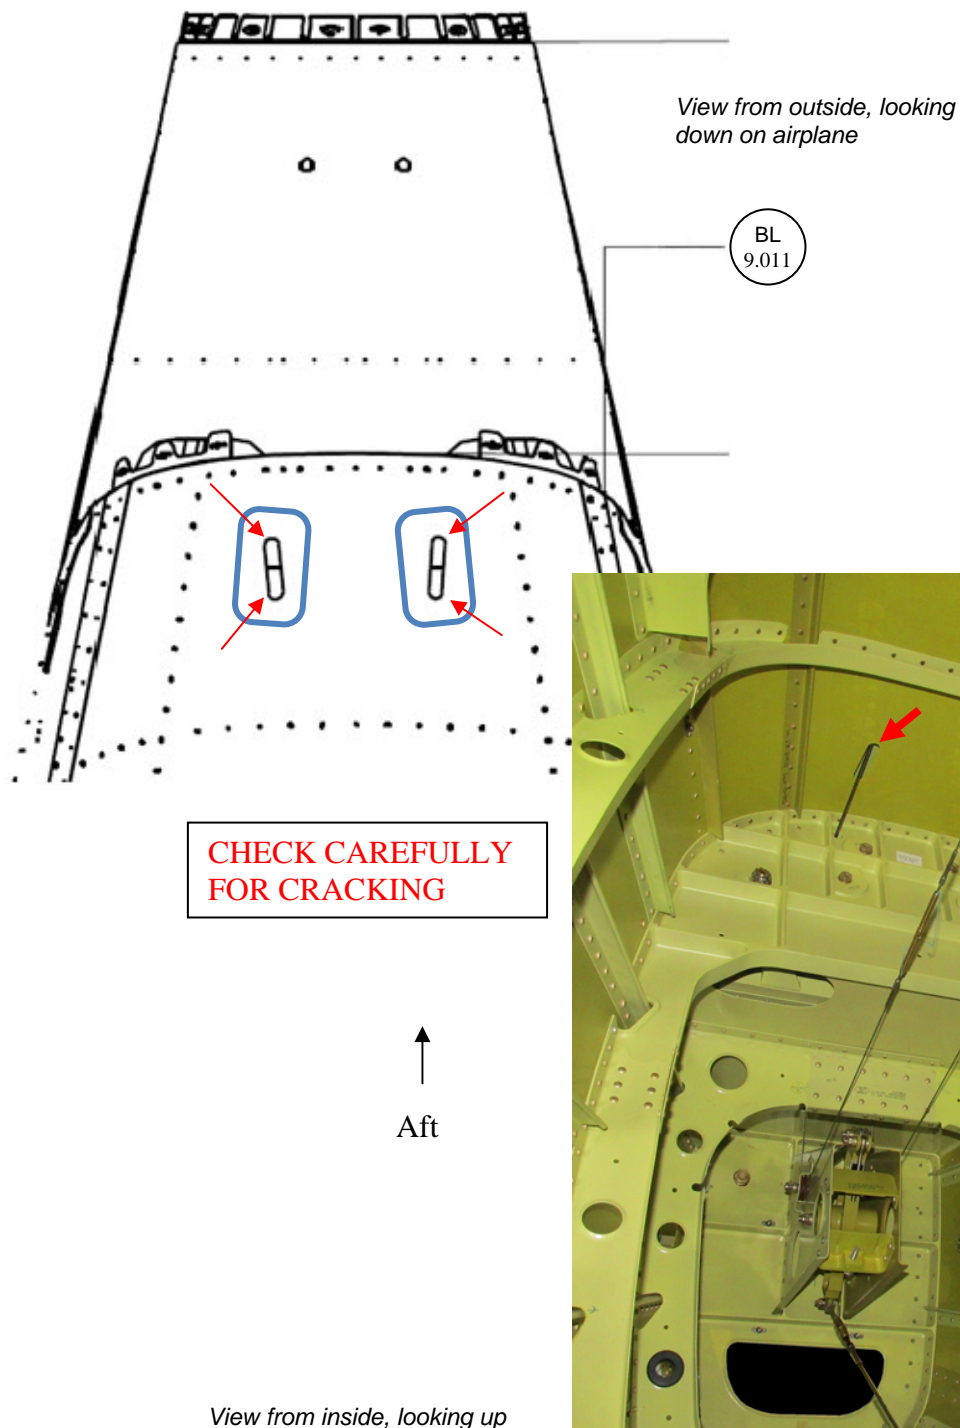
Figure 5-1: Rudder Cable Pass-Through Hole Perimeter Crack Check

Using the following procedure based on AC43.13-1B, Section 2, visually inspect for cracking around the perimeter of the rudder cable pass-through holes as indicated in **Figure 5-1**.

3. Paying particular attention to the radii at the ends of the pass-through slots, carefully inspect the area for discontinuities, using optical aids as required. An inspector should have available, at minimum, a flashlight and a mirror.

5. If cracks are found, determine the maximum extent of the cracking and check to ensure that the complete extent of the crack can be removed when the perimeter of the rudder-cable pass-through holes is reshaped as described in **Section 5.3**.

- a. If all cracks can be completely removed by the trimming procedure described in **Section 5.3**, proceed to **Section 5.3** of this Field Service Instruction.

- b. If all cracks cannot be completely removed by the trimming procedure described in **Section 5.3**, then notify Quest Customer Service of the existence of the cracking and request additional instructions.
