# \*MANDATORY SERVICE BULLETIN\*

**NUMBER:** SB 14-09 **REVISION:** 01 **DATE:** 12/11/2014

**SUBJECT: ELEVATOR DOUBLER INSTALLATION**

**Elevator Doubler Installation**

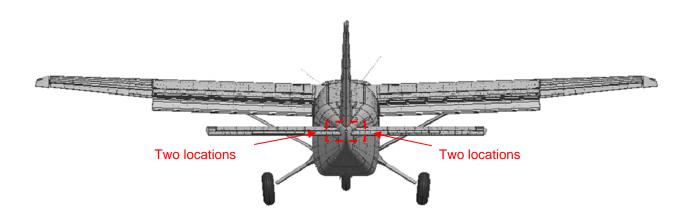
Figure 3-1: Overview

This Field Service Instruction provides procedures for inspecting for cracking of the inboard upper and lower skins of the elevator and installation of doublers to repair existing cracking or prevent cracks from occurring.

Inspect a total of four locations on the airplane and perform repairs/install doublers at each in accordance with the instructions in Section 4.0 and Section 5.0.

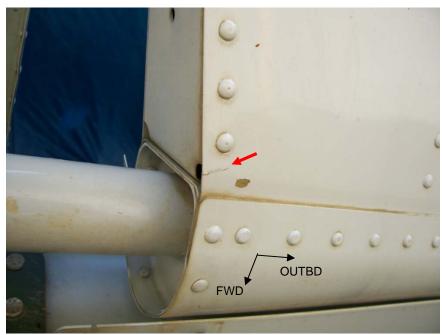
Figure 4-1: Example of Cracking

Quest Aircraft received one report of cracks forming in the trailing edge skin of the elevator on the lower inboard corner, near the leading edge skin and torque tube. QUEST® has determined that the area must be inspected on every aircraft as specified below, and doublers installed. The attached Field Service Instruction provides procedures for inspecting for cracking of the inboard upper and lower skins of the elevator and installation of doublers to repair existing cracking or prevent cracks from occurring.

Bottom side of right elevator shown

- 2. Inspect the elevator, both top and bottom, for signs of cracking in the forward inboard end of the trailing edge skin, aft of the spar (Figure 4-1) by using the following procedure based on AC43.13-1B, Section 2:
  - a. Provide adequate lighting to illuminate the edges of the elevator trailing edge skin.
  - b. Clean the areas to be inspected. Remove any contaminants that might hinder the discovery of existing surface indications. Do not remove the protective finish from the part or area prior to inspection.

- c. Carefully inspect the area for discontinuities, using optical aids as required. An inspector should have available, at minimum, a flashlight and a mirror.
- d. Determine the extent of any cracks found by directing the light beam at right angles to the crack and tracing its length. Use a 10-power magnifying glass to confirm the existence of a suspected crack.
- 3. **For locations where no cracking is found:** proceed to **Section 5.1**, Uncracked Elevator Skins Install Doubler.
- 4. **For locations where cracking is found:** proceed to **Section 5.2**, Cracked Elevator Skins Repair Cracking and Install Doubler.
