RECOMMENDED SERVICE BULLETIN**SUBJECT: YOKE ANTI-ROTATION GUIDE WEAR PAD UPGRADE****REVISION: 00****DATE: 03/26/2015****EFFECTIVITY: KODIAK[®] 100 series airplane serial numbers 100-0001 thru 100-0149****SUMMARY**

Yoke Anti-Rotation Guide Wear Pad Upgrade

FSI-108

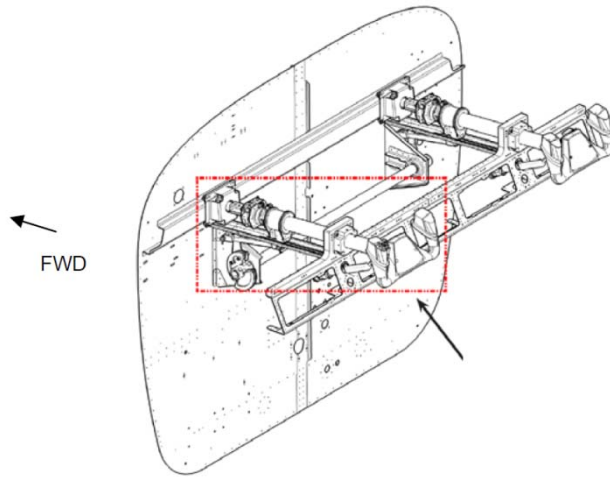
Figure 3-1: Overview

The instructions included in this document remove the existing Cushion Edging (P/N: M22529/3-2R-25) installed on the anti-rotation guide and install a total of four (4) new wear pads attached to the elevator bearing assembly link arm. This document supersedes Quest Mandatory Service Bulletin SB14-07 which included FSI-105, *Elevator Control System – Cushion Edging Inspection*.
