**MANDATORY SERVICE BULLETIN****SUBJECT:** Elevator Control System – Cushion Edging Inspection**REVISION:** 01**DATE:** 11/23/2015**EFFECTIVITY:** KODIAK 100 Series Aircraft Serial Numbers 100-0001 through 100-0149**SUMMARY**

TITLE: Elevator Control System – Cushion Edging Inspection

REPORT NO.: FSI-105

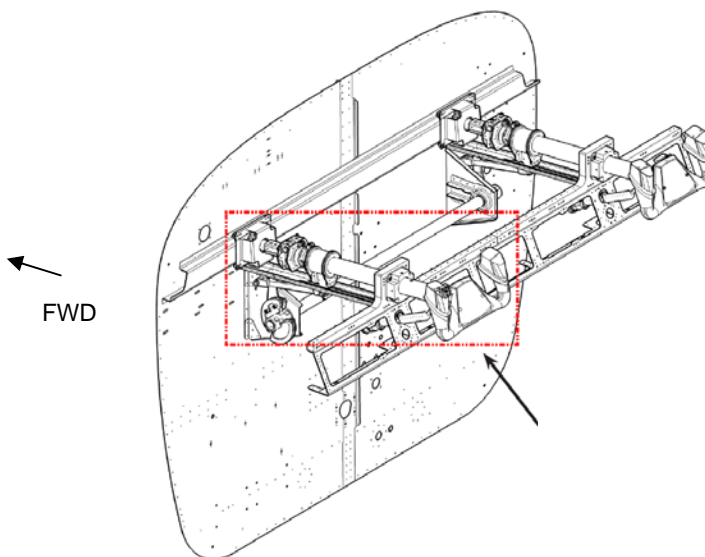
**Figure 3-1: Overview**

One operator reported to Quest Aircraft Customer Service that during a preflight inspection on the control yoke (FREE and CORRECT), the elevator became stiff and felt jammed. The pilot inspected the control yoke system forward of the control yoke and found cushion edging (P/N M22529/2-3R-25) jammed in the elevator control anti-rotation guide (P/N 100-619-0008) slot. The jammed edging prevented the control yoke from having full nose up and down travel. A second report was sent to Quest Aircraft Customer Service which showed the cushion edging plastic portion separated from the metal track on a different KODIAK® 100 aircraft.

After investigation it has been discovered that over time the edging may become worn and degrade. To ensure the edging remains in place and functions as required, Quest is mandating inspections and replacement on condition in accordance with **Section 5.1** and **Section 5.2** of this Field Service Instruction for all KODIAK® 100 aircraft.

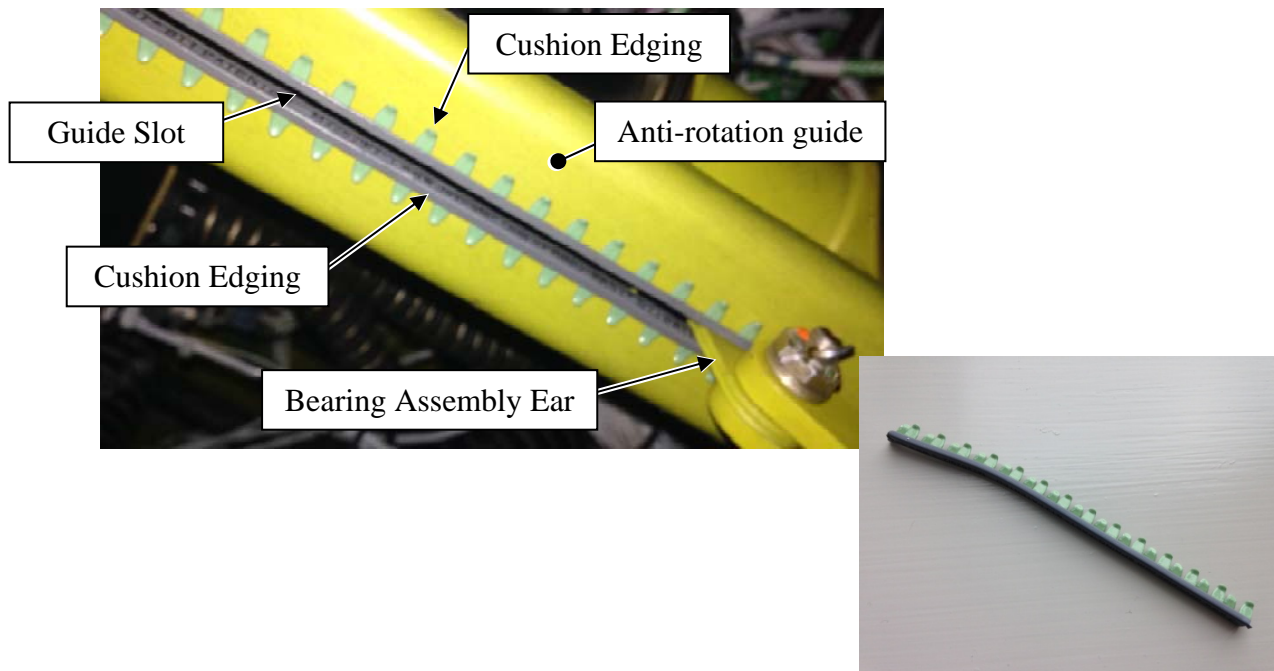
**Figure 5-1: Cushion Edging**

1. Inspect the cushion edging (**P/N M22529/2-3R-25**) located on each side of the elevator control anti-rotation guide slot (**P/N 100-619-0008**) to ensure it runs the full length of the slot; reference **Figure 5-1**. If the cushion edging does not run the full length of the slot, replace the edging in accordance with **Section 5.3**.
2. Inspect the cushion edging located on each side of the elevator control anti-rotation guide slot for general condition, wear, and security; reference **Figure 5-1**. If wear is found, replace the cushion edging in accordance with **Section 5.3**.

1. Detach the existing cushion edging (P/N M22529/2-3R-25) and remove from the aircraft.
2. Cut a length of new cushion edging (P/N M22529/2-3R-25) to a length of  $9.00 \pm 0.10$  inches.
3. Slide the cushion edging into position.
