MANDATORY SERVICE BULLETIN**SUBJECT:** AILERON LEADING EDGE SKIN AND NOSE RIB INSPECTION**REVISION:** 01**DATE:** 01/27/2016**EFFECTIVITY:** KODIAK® 100 Series airplanes equipped with aileron P/N 100-345-0100 (Left) or P/N 100-345-0200 (Right) that have not performed FSI-045 or FSI-053.**SUMMARY**

TITLE: Aileron Leading Edge Skin and Nose Rib Inspection Procedures

PAGE: 1 of 8
REPORT NO.: FSI-069
REVISION: 00

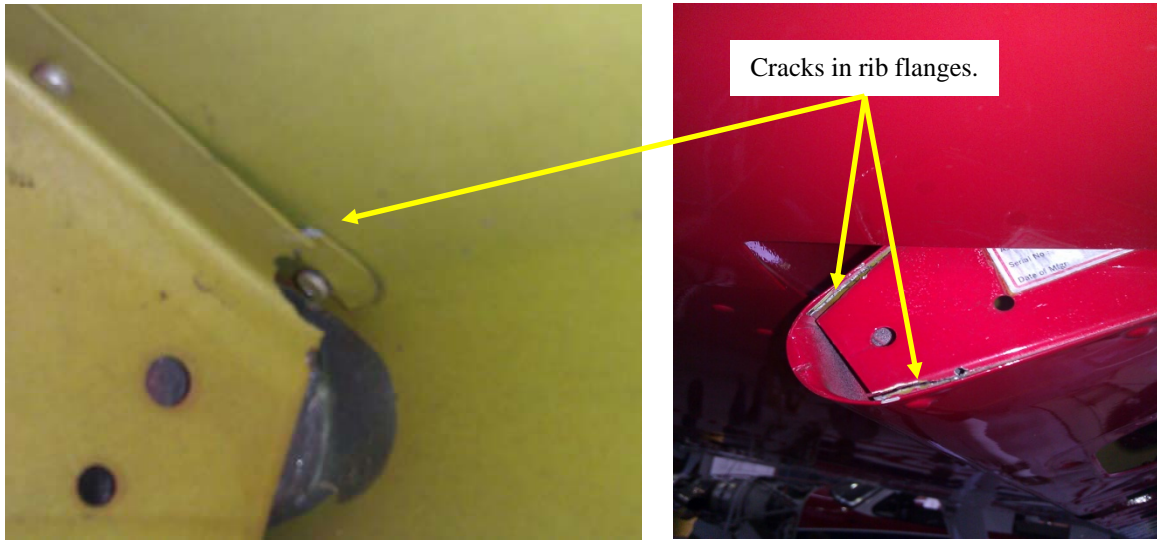
Figure 5-1: Example of Rib Flange Crack

1. Inspect the rib flanges for cracks and general condition. Refer to **Figure 5-1** for examples of structural damage.

1. Cracks may be stop drilled with a #40 (0.098 inch) to #30 (0.128 inch) diameter hole only if the following limitations are met:
 - Maximum crack lengths, including stop drills, shall be 0.50 inch individually and 2.00 inch combined for all cracks in an aileron.
 - The maximum combined crack length in any given rivet row or rib flange shall be 0.50 inch.
2. If cracks present exceed the limitations of Step 1, they cannot be stop drilled. Contact Quest Customer Service to receive Field Service Instructions to replace specific ribs and/or leading edge skins, or to request a replacement aileron.

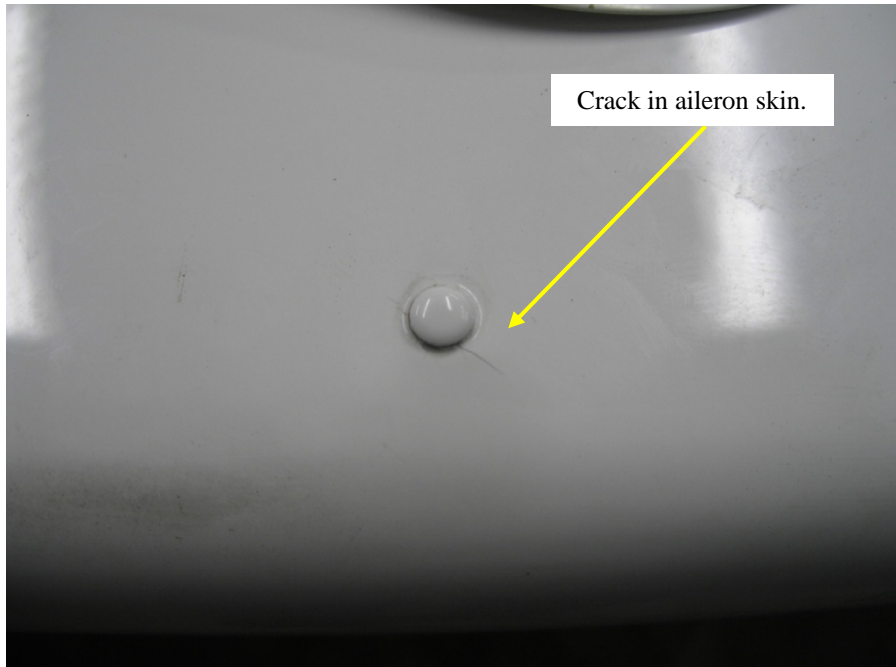
Figure 5-2: Example of Leading Edge Skin Crack

2. Inspect the leading edge skin around the ribs, on the inside and outside, for cracks, chips, and general condition. Refer to **Figure 5-2**.
