RECOMMENDED SERVICE BULLETIN**SUBJECT:** SB16-02**REVISION:** 00**DATE:** 02/17/2016**EFFECTIVITY:** KODIAK 100 Series Airplane Serial Numbers 100-0086 thru 100-0110 or airplanes subsequently equipped with the Flap Gearbox Controller (also referred to as "Gearbox/Controller") and/or Aileron Trim Actuators listed in FSI-129.**SUMMARY**

TITLE: Flap Gearbox Controller and Aileron Trim Actuator Replacement

REPORT NO.: FSI-129

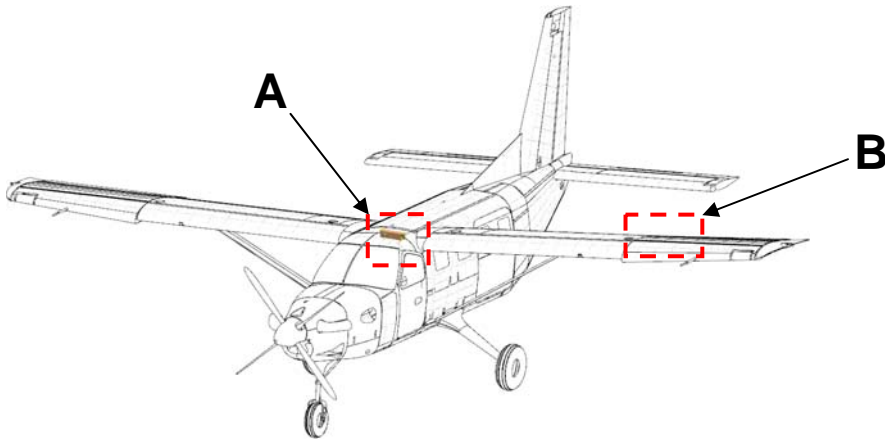
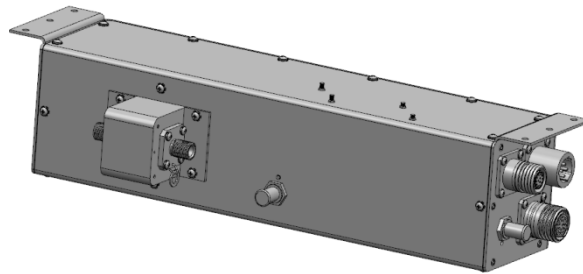
DETAIL A
Gearbox/Controller

Suspect gears were installed in the Gearbox/Controller (P/N 100-621-0113) and Aileron Trim Actuator (P/N 100-624-0100). The over-hard gears installed in the Gearbox/Controller are used in a location of low torque, and no functional issue is expected to occur. The over-hard gears installed in the Aileron Trim Actuator might eventually cause the actuator to exhibit one of the symptom listed above. Quest recommends that suspect Gearbox/Controllers or Aileron Trim Actuators be sent back to Quest.

The Gearbox/Controller is located between the wings, in the passenger cabin, and above the headliner. See **Figure 3-1, Detail A**.

5.1 Replace Gearbox/Controller

1. Remove the Gearbox/Controller in accordance with AM902.0, *KODIAK 100 Airplane Maintenance Manual*, Chapter 27.
2. Install the replacement Gearbox/Controller unit in accordance with AM902.0, *KODIAK 100 Airplane Maintenance Manual*, Chapter 27.

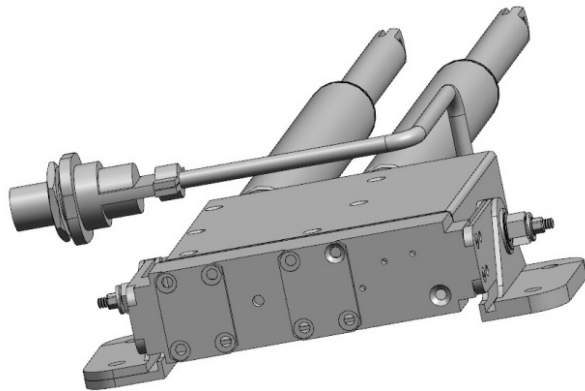
DETAIL B
Aileron Trim Actuator

The aileron trim actuator is located in the left wing. See **Figure 3-1, Detail B**.

5.2 Replace Aileron Trim Actuator

1. Remove the Aileron Trim Actuator in accordance with AM902.0, *KODIAK 100 Airplane Maintenance Manual*, Chapter 27.
2. Install the replacement Aileron Trim Actuator unit in accordance with AM902.0, *KODIAK 100 Airplane Maintenance Manual*, Chapter 27.
3. Return the affected part to Quest Customer Service.
