MANDATORY SERVICE BULLETIN

NUMBER: SB-011

SUBJECT: FLIGHT SURFACES; ADJUSTMENT

KODIAK 100 Series Aircraft, Serial Numbers 100-0001 through 100-0003

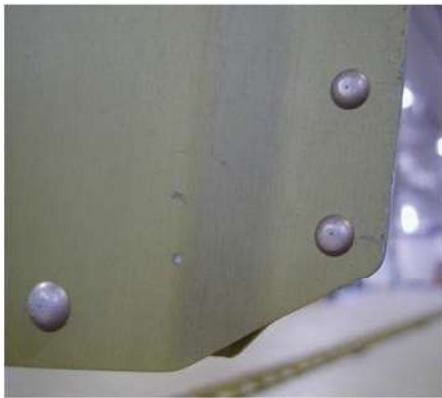
Figure 1: Rudder Trimming

This Service Bulletin contains instructions to increase the clearance between the rudder and elevator flight control surfaces.

Follow the instructions contained in this Service Bulletin to increase the clearance between the rudder and elevator control surfaces.
