MANDATORY SERVICE BULLETIN

NUMBER: SB11-07
REVISION: 00
DATE: 07/01/2011

SUBJECT: Nose Gear Piston Tube Cap Replacement

KODIAK 100 Series Aircraft, Serial Numbers 100-0046 and 100-0052.

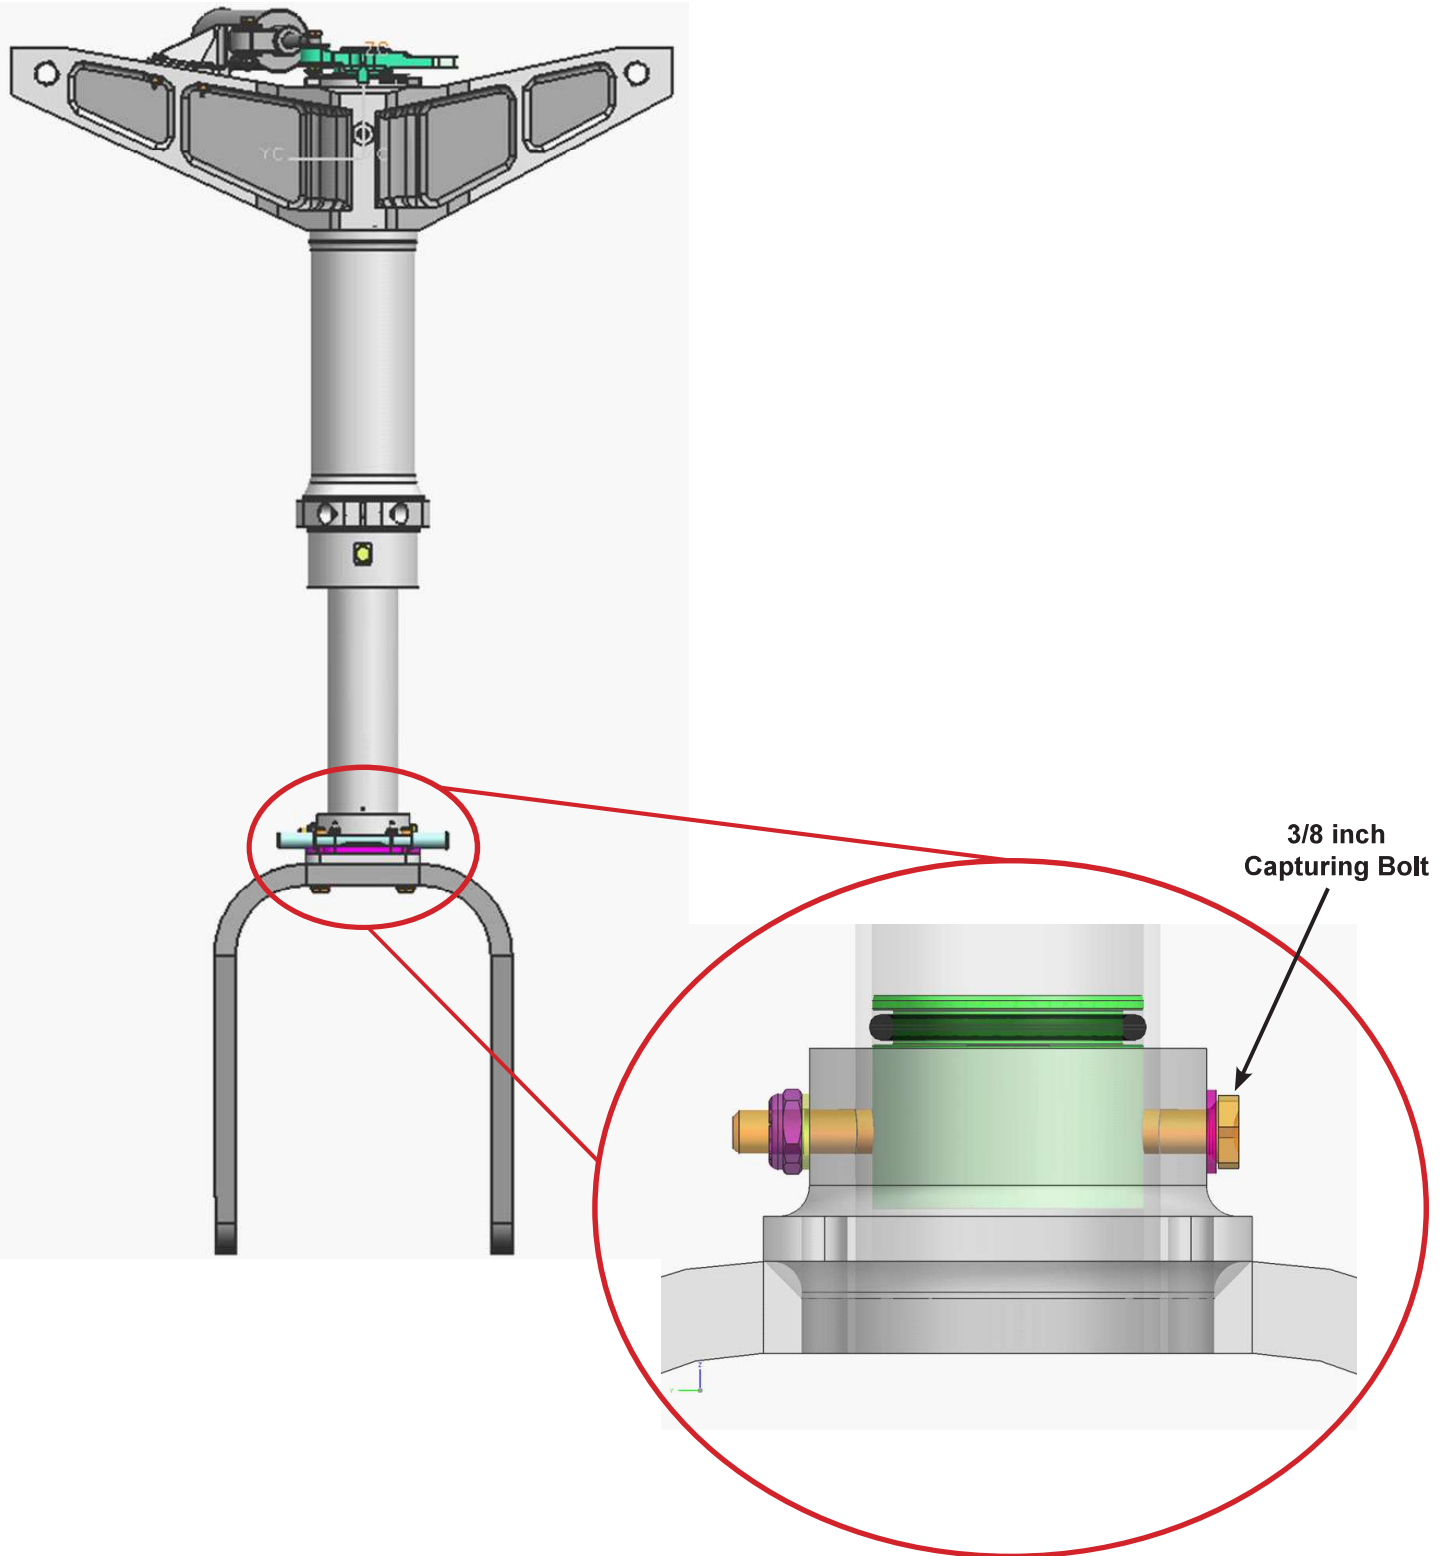
Figure 1-1 – View of the Nose Gear (with expanded view of nose gear piston tube cap)

Quest has become aware of an issue with the nose gear piston tube cap (P/N **100-412-0103**) on certain airplanes. Our vendor inadvertently manufactured these parts from a different alloy of material than required in our approved design. We have investigated the effect of this deviation and have concluded in conjunction with FAA engineering that this does not affect the functionality or safety of the part. However, due to the parts not meeting the exact type design specifications, we are issuing a recall of the part. A new part will be provided by Quest, and should be used to replace the noncomplying part on your airplane.

Quest is mandating the replacement of the nose gear piston tube cap on the affected aircraft. Refer to the next part of this Service Bulletin for instructions on how to remove the old nose gear piston tube cap and install the new nose gear piston tube cap.
