MANDATORY SERVICE BULLETIN

NUMBER: SB11-08
REVISION: 00
DATE: 06/24/2011

SUBJECT: SPAR PASS-THRU HOLE AND TAILCONE MODIFICATION

KODIAK 100 Series Aircraft Serial Numbers: 100-0001 through 100-0045.

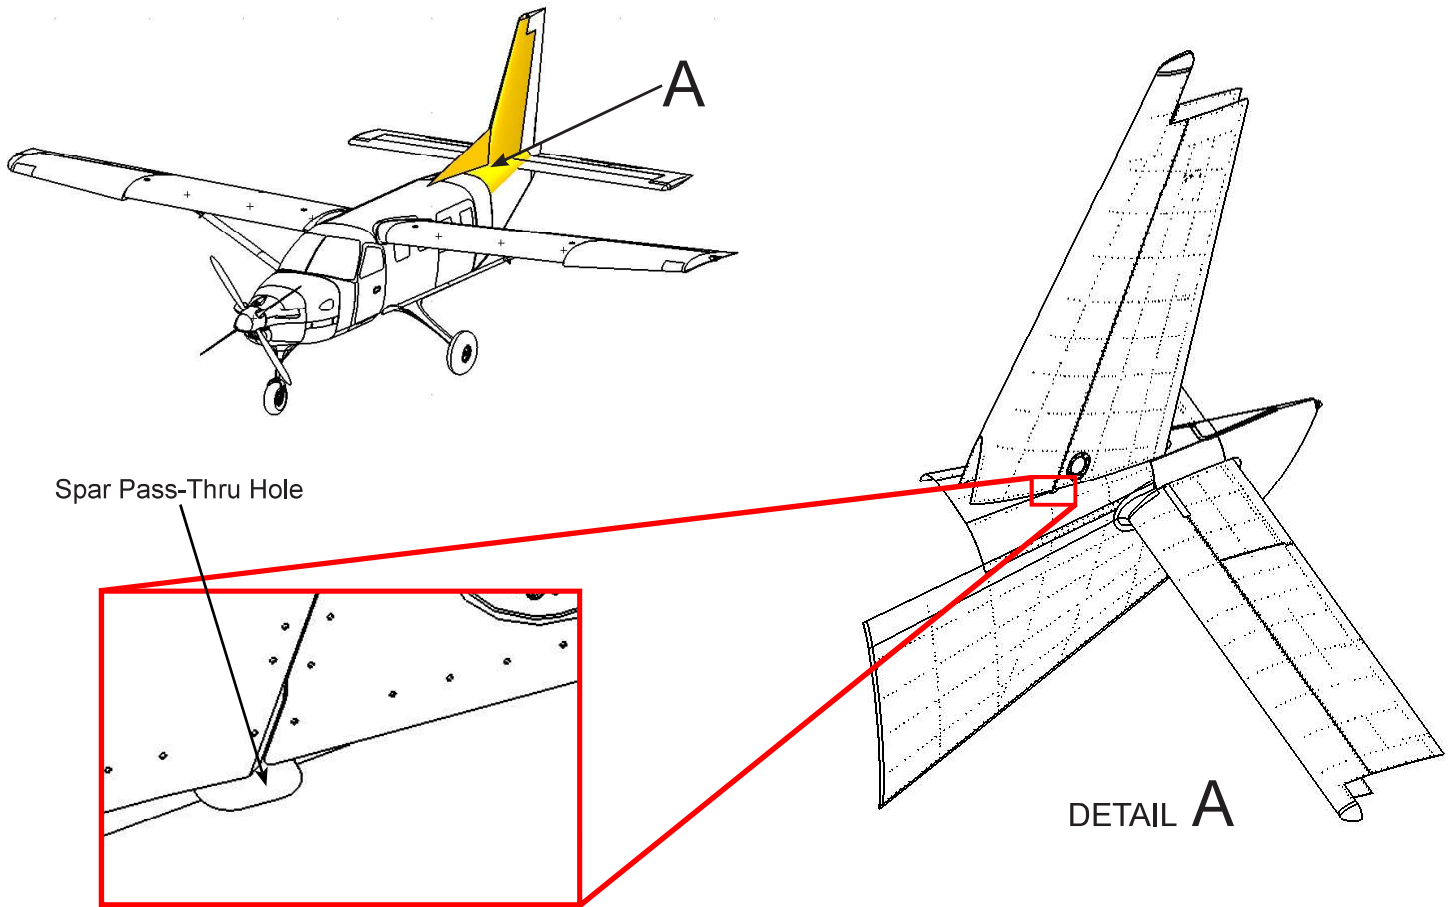
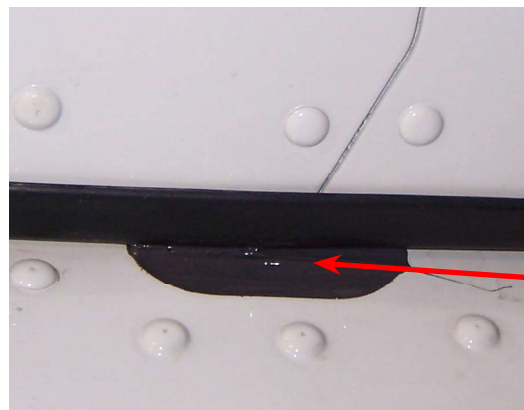
Figure 1-1: Spar Pass-Thru Hole Modification

It has been determined that the mount design of the vertical tail leaves two uncovered areas in the top of the fuselage that allows fluid entry into the area AFT of the rear interior bulkhead. This fluid does not adequately drain, and has a potential to negatively affect some of the electronics.

**NOTE:** Sealant application should be mirrored on the right side of the aircraft.

Quest is mandating the installation of a sealant over the area indicated in **Figure 1-1**, as well as the installation of two (2) drain grommets on the underside of the tailcone.

1. Remove the AFT bulkhead from the aircraft as shown in the KODIAK 100 Maintenance Manual (P/N 490770).
2. Clean the interior and exterior surfaces around the spar pass-thru holes shown in **Figure 1-1** using a lint-free cloth and denatured alcohol or equivalent.
3. Apply masking tape to the inside surface of the aircraft skin covering the spar pass-thru holes shown in **Figure 1-1**.

1. Apply ProSeal® (P/N **P/S 890 B-2**) into the spar pass-thru holes shown in **Figure 1-1** on both sides of the aircraft. Ensure the sealant adheres around the perimeter of the holes and is faired to the upper surface of the aircraft skin with a 0.06" to 0.13" overlap over the edges of the hole.
2. Follow all manufacture's safety and cure time instructions.
3. Remove the masking tape applied to the inside surface of the aircraft skin.
4. Reinstall the AFT bulkhead into the aircraft as shown in the KODIAK 100 Maintenance Manual (P/N 490770).
