SERVICE NOTICE

NUMBER: SN-021
REVISION: A
DATE: 12/07/2009

SUBJECT: GARMIN SERVICE BULLETIN 0823, REVISION C

SUBJECT: GDU 104X CRS/BARO Knob Interference

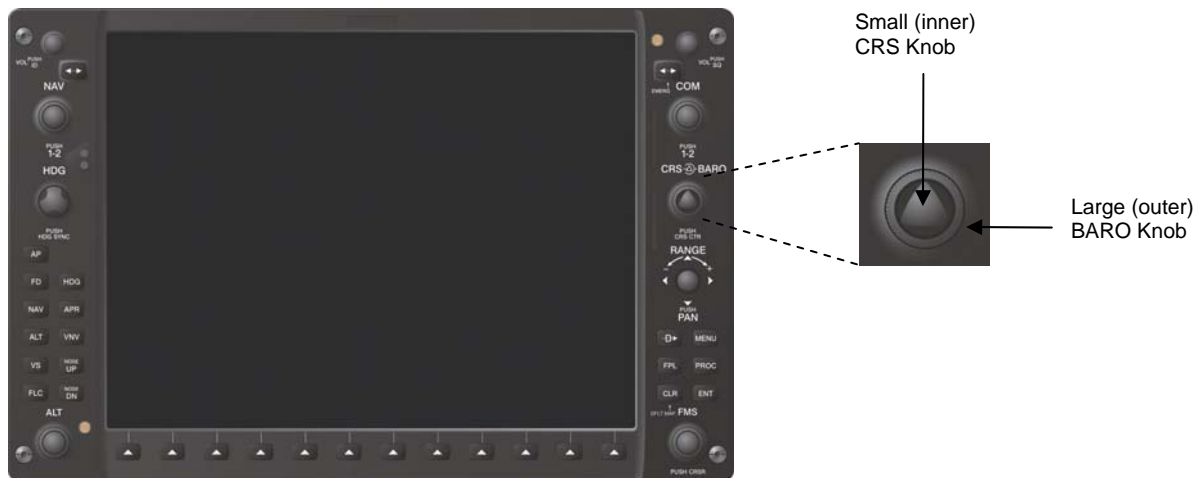
Figure 1

Garmin has identified an issue, whereby the large (outer) BARO knob and the small (inner) CRS knob may interfere with each other.

If CRS/BARO Knob interference is confirmed, perform the steps below to replace the CRS/BARO Knob. New knobs can be obtained through a Garmin Service Center or Aircraft OEM under Garmin part number K00-00446-00.

1. Grasp the small (inner) CRS knob and firmly pull the knob off the shaft.
2. Discard knob.
3. Grasp the large (outer) BARO knob and firmly pull the knob off the shaft.
4. Discard knob.

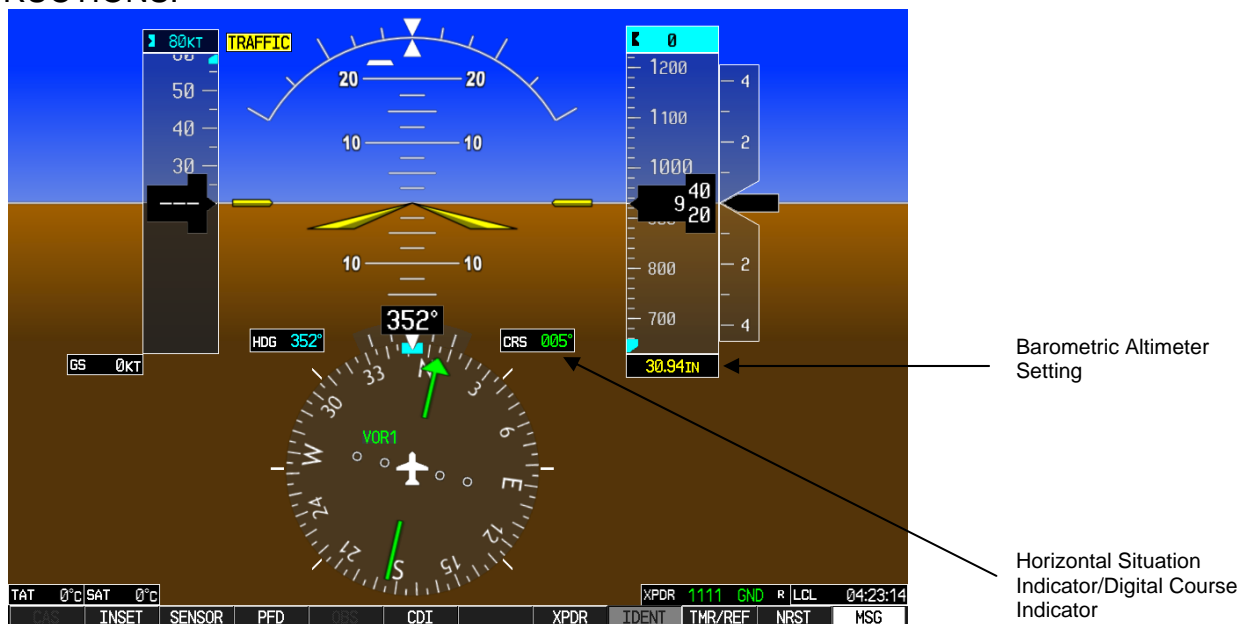
Figure 3

4. Rotate the small (inner) CRS knob (refer to Figure 1) a minimum of three complete revolutions in each direction while monitoring the Barometric Altimeter Setting (refer to Figure 3) on the PFD. If a change in the Barometric Altimeter Setting is produced while turning the CRS knob proceed to the Modification Instructions.
5. Repeat Steps 3 and 4 for each affected GDU.
