## SERVICE NOTICE

**NUMBER:** SN-022

**SUBJECT:** GARMIN SERVICE ALERT 0824, REVISION C

**TO:** All G1000/G900X/G950 Owners and Operators  
**DATE:** 20 November 2009  
**SUBJECT:** GDU 104X CRS/BARO Knob Interference  
**REVISION C:** Added note regarding Service Bulletin 0823 in Affected Products section

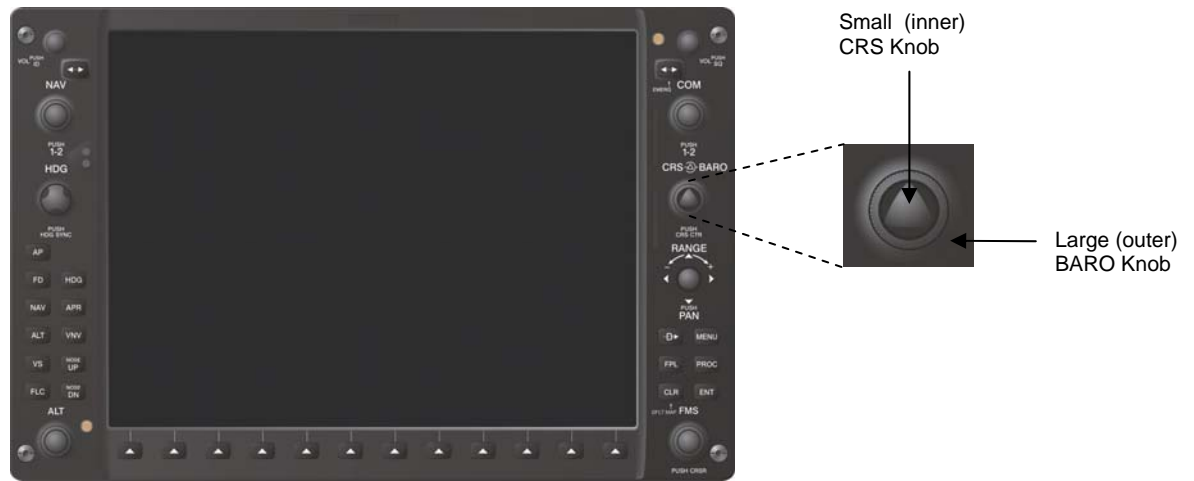
**Figure 2**

Garmin has identified an issue, whereby the large (outer) BARO knob and the small (inner) CRS knob may interfere with each other.

1. Apply power to the G1000/G900X/G950.
2. Press the CDI softkey on the Primary Flight Display(s) (PFD) to enter VOR mode on the HSI.
3. Rotate the large (outer) BARO knob (refer to Figure 2) a minimum of three complete revolutions in each direction while monitoring the Horizontal Situation Indicator/Digital Course Indicator (refer to Figure 3) on the PFD. If a change in the Horizontal Situation Indicator/Digital Course Indicator is produced while turning the BARO knob contact your local Garmin Service Center or OEM Dealer to replace the knobs.

4. Rotate the small (inner) CRS knob (refer to Figure 2) a minimum of three complete revolutions in each direction while monitoring the Barometric Altimeter Setting (refer to Figure 3) on the PFD. If a change in the Barometric Altimeter Setting is produced while turning the CRS knob contact your local Garmin Service Center or OEM Dealer to replace the knobs.
5. Repeat Steps 3 and 4 for each affected GDU.
