FIL.2024-T13

Kodiak- Bleed Air Heat Malfunctions

July 2024

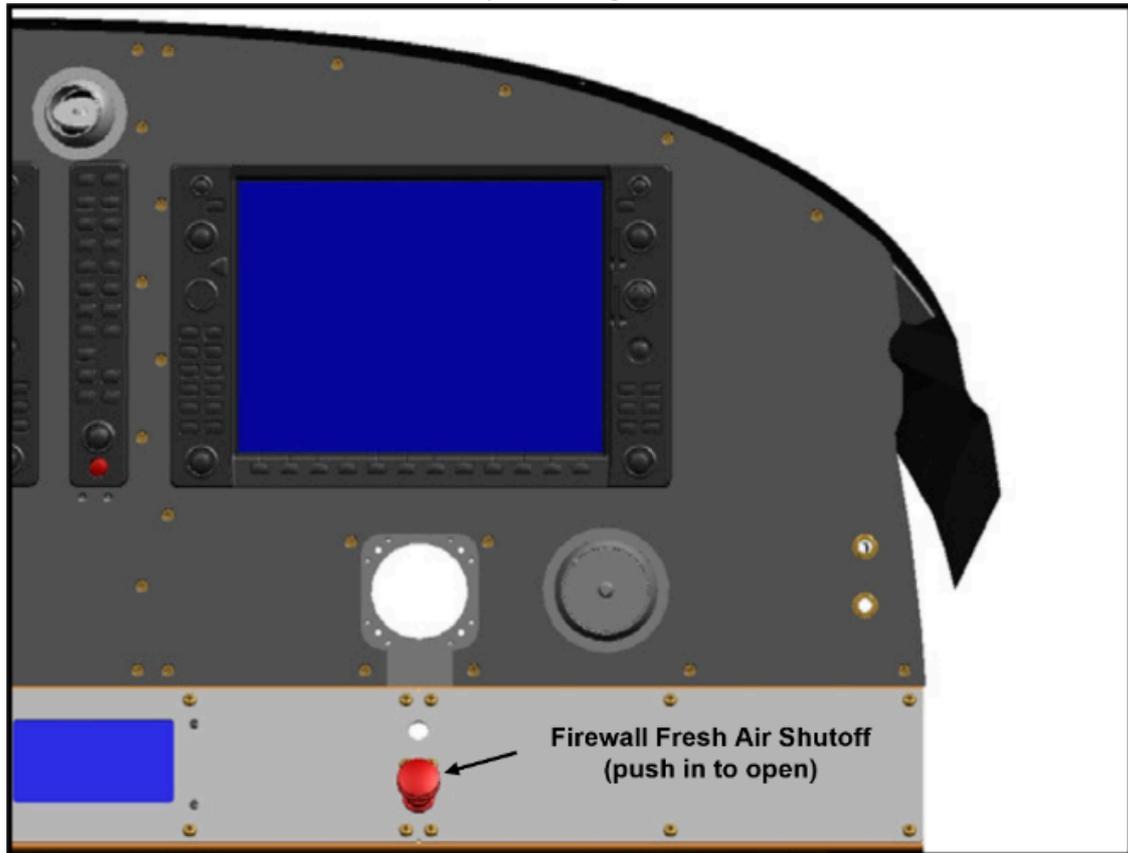
Kodiak 100 Instrument Panel Layout, Right Side

air (including Bleed Air) from forward of the firewall. The valve is controlled by a red knob located on the instrument panel, just below the right control yoke.
