# \*MANDATORY SERVICE BULLETIN\*

NUMBER: SB-022 REVISION: B DATE: 10/30/2009

SUBJECT: PITOT STATIC SYSTEM; MANDATORY MODIFICATION

KODIAK 100 Series Aircraft, Serial Numbers 100-0001 through 100-0022

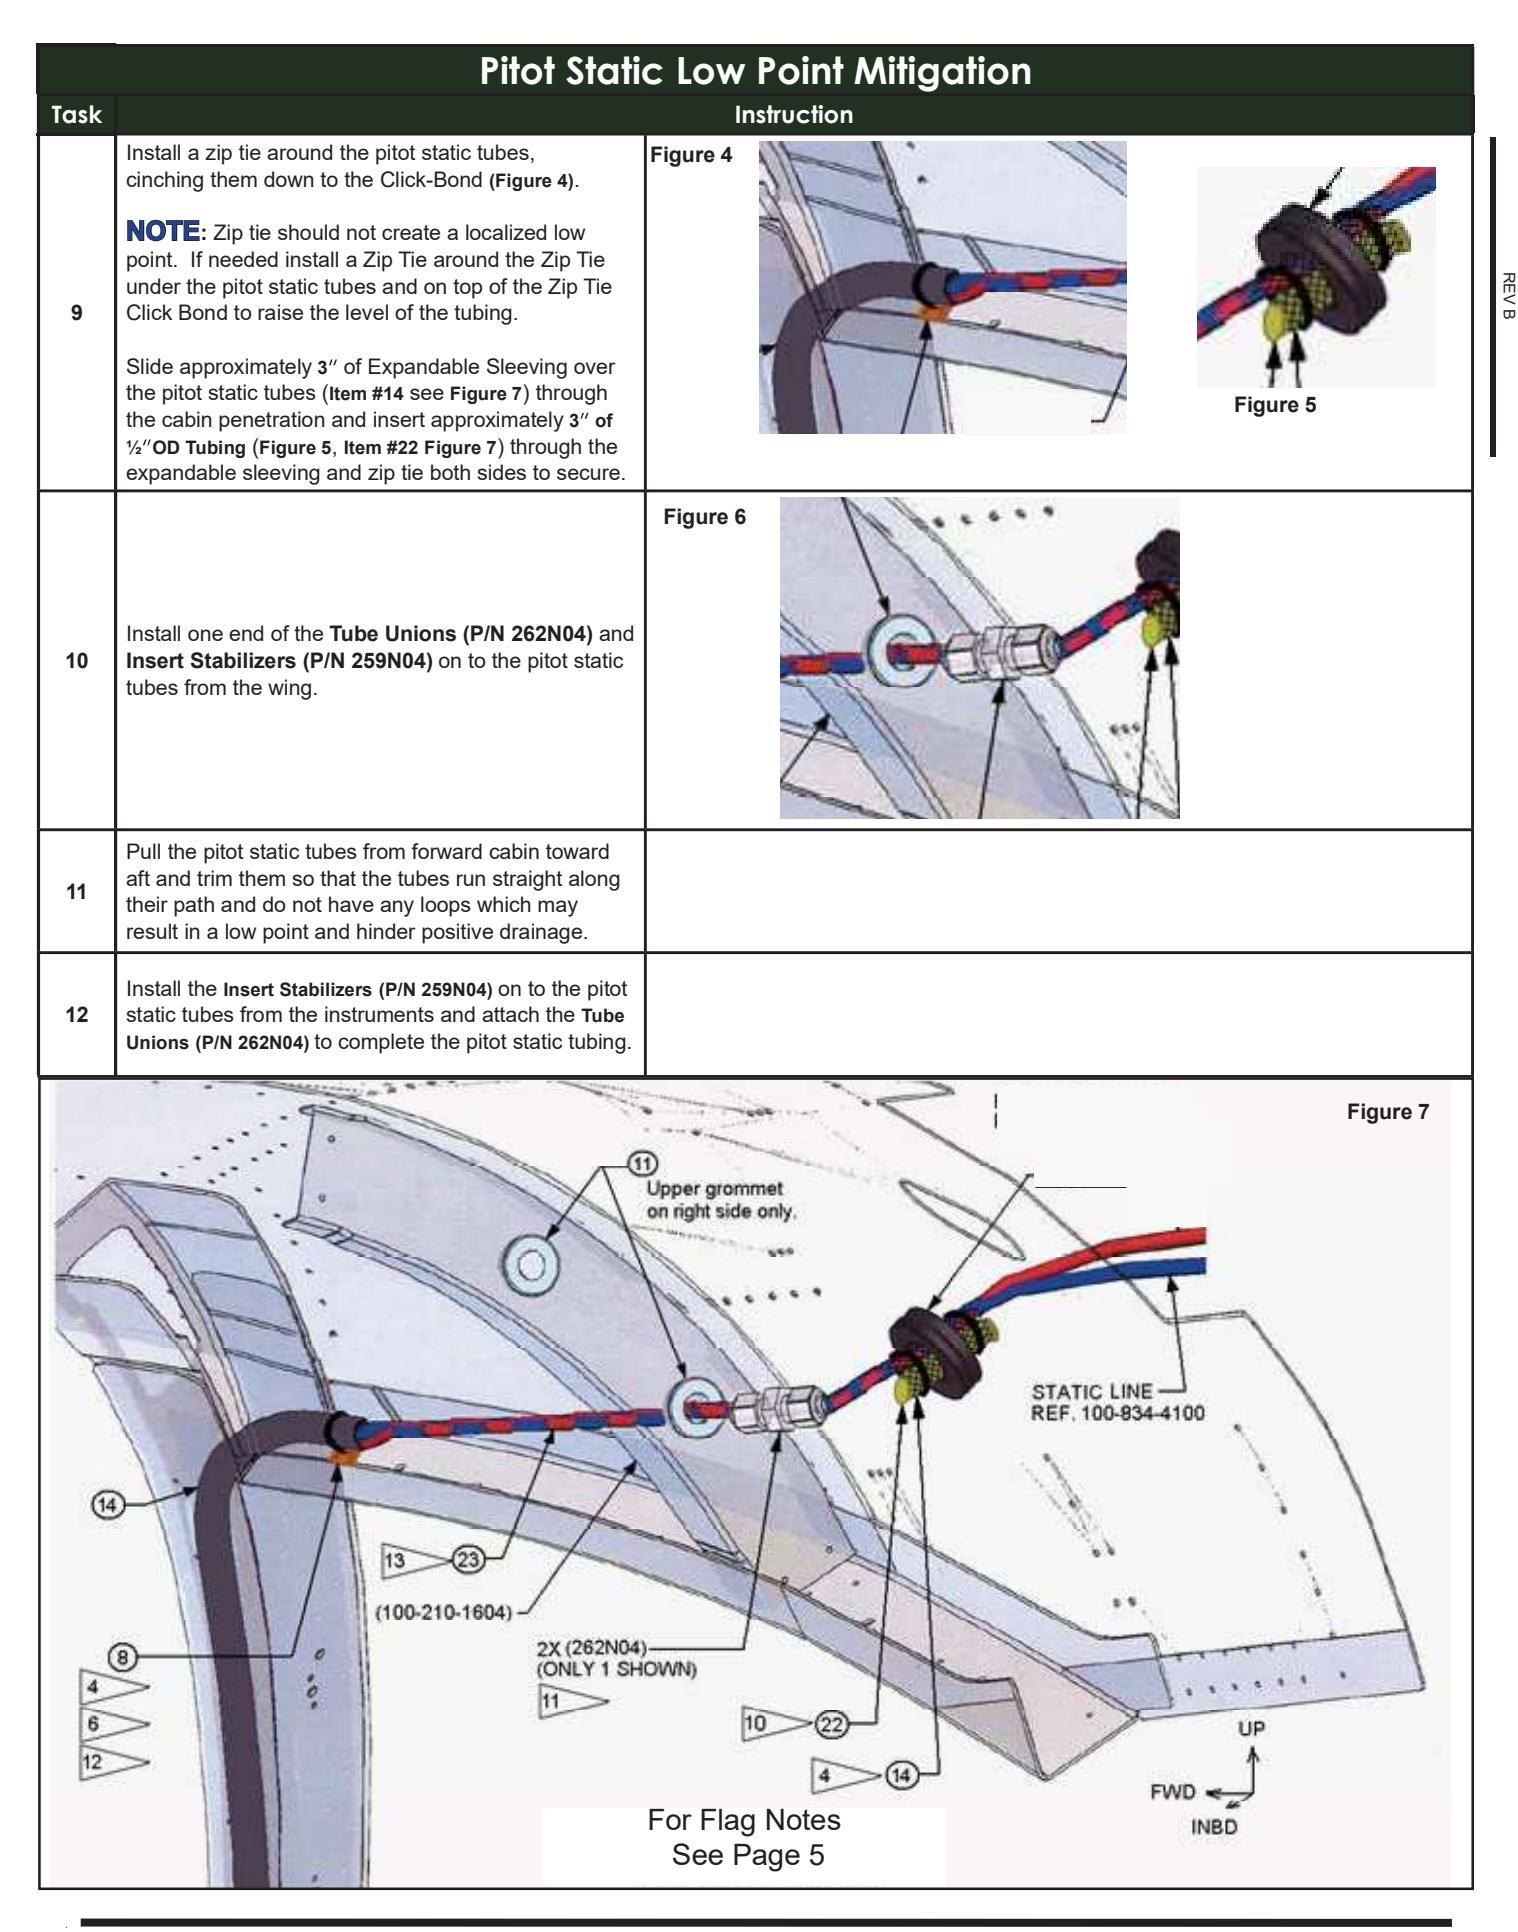
Quest has identified four potential low spots in the pitot static routing. Quest is mandating a one time modification to eliminate the potential for a low spots in the pitot static system.

Pitot Static Low Point Mitigation		
Task		Instruction	
1	Remove the forward Cabin Ceiling Panels (2) over crew doors in accordance with the KODIAK Mainte- nance Manual.		
2	Locate the frames ( <b>P/N 100-210-1604</b> ) that the pitot static lines run through, on the left and right sides of the cabin.	Figure 1	
3	Remove the Zip Tie Click-Bond (P/N CB9120V5) from its holder. Install Zip Tie Click-Bond (Item #8 see Figure 7) on the crew door frame structure above both pilot and copilot doors using Click-Bond Adhesive (P/N CB200). Use tape to temporarily apply positive pressure to the Zip Tie Click-Bond while the adhesive cures.		
4	At the lowest location of the pitot static tubes, mark where to cut the tubes. Label the tubes on both sides of the mark (one red, one blue) in order to correctly connect them again. Cut the tubes at the marks.	Figure 2	
5	Pull the tubes forward out of the frame (P/N 100-210-1604) from above the crew door and remove the rubber grommet from the frame. NOTE: On the right side of the cabin, simply remove the rubber grommet from the frame and slide it up the electrical wires.

6	Cleco the Pitot Static Re-Route Drill Plate tool (P/N 100-210-1604-0015) to the frame (P/N 100-210-1604) and drill a 1/8" hole. This will locate the new 3/4" hole per <b>Figure 3</b> . Remove clecos and Pitot Static Re-Route Drill Plate. Upsize the hole to 0.750" +/- 0.010"	Figure 3	
7	Install a rubber grommet (P/N MS35489-149) (Item #11 see Figure 7) in the new hole. NOTE: On the right side of the cabin, slide rubber grommet back into existing hole to protect the wiring.		
8	Feed the pitot static tubes aft through the new hole.
