MANDATORY SERVICE BULLETIN

NUMBER: SB11-13

SUBJECT: Horizontal Attach Fitting Aft Spar Inspection

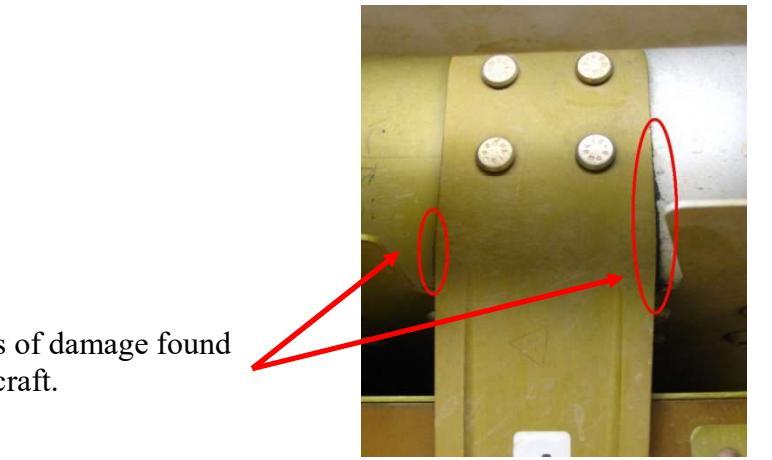
Examples of damage found on an aircraft.

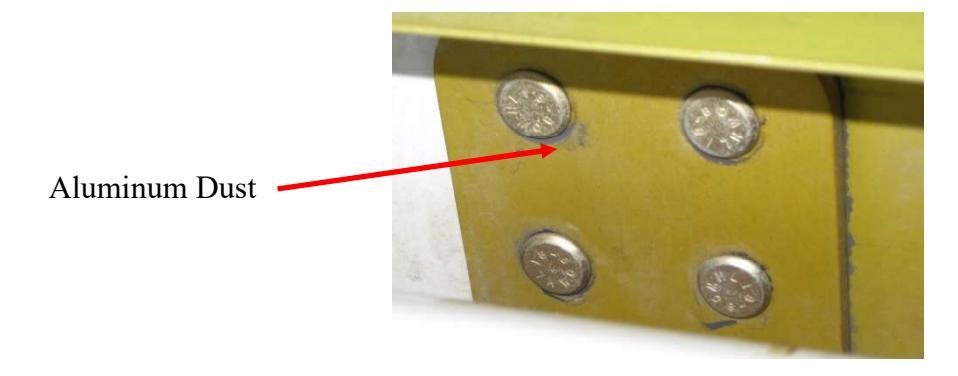
2.4. Inspect around each fastener head for evidence of aluminum dust or shavings.

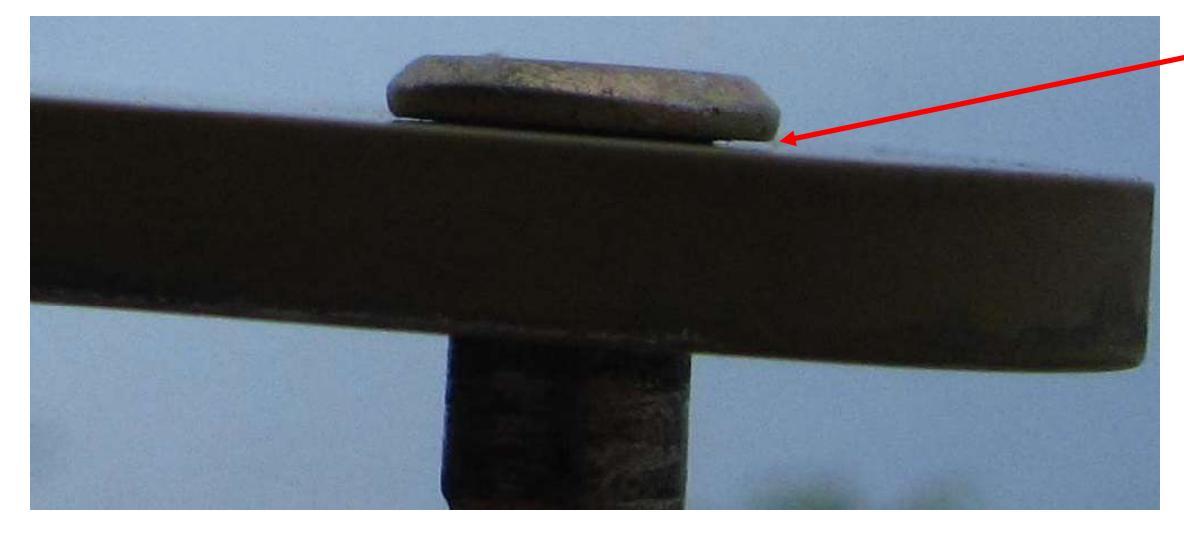
- 2.5.3. In the image shown below, the aft attach fitting has been removed from the aircraft. Note that the fastener is fully seated in the hole, yet a gap exists between the head of the fastener and aft attach fitting. This condition should be inspected for and problems reported to Quest Aircraft Company prior to further flight.

Gap between the fastener and attach fitting.

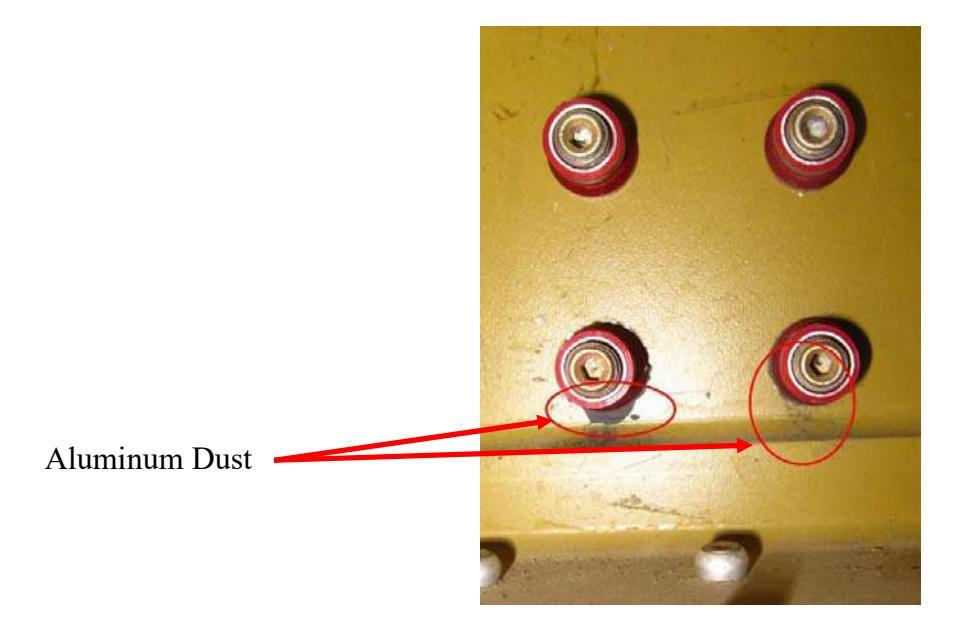
3. Inspect the forward (inside) side of the spar web for evidence of aluminum dust or shavings. See the photo below.
