MANDATORY SERVICE BULLETIN

SUBJECT: Rudder Pulley Bracket Inspection REVISION: 00 DATE: 06/09/2015 EFFECTIVITY: KODIAK[®] 100 Series Airplane Serial Numbers 100-0082 thru 100-0107

Rudder Pulley Bracket Assembly Inspection

FSI-116

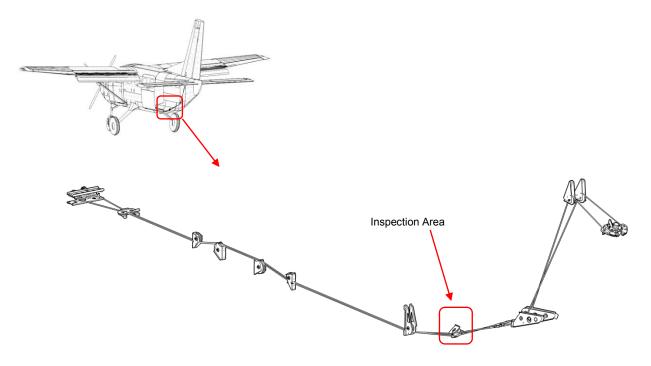
Figure 3-1: System Overview

This instruction provides procedures for the inspection of the rudder pulley bracket assembly located in the aft end of the airplane (FS 208.000) as indicated in **Figure 3–1**. Inspect rudder pulleys for wear and rudder cables for damage or corrosion.

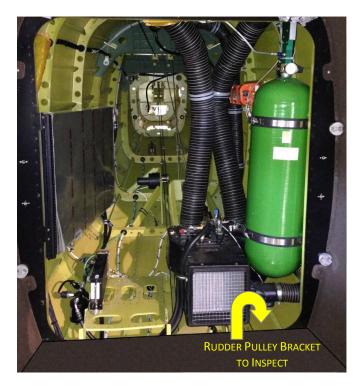
Figure 5-1: Rudder Pulley Bracket Assembly Location

Inspect the rudder pulley bracket assembly and rudder cables, whose general location is indicated in **Figure 5-1**. The pulley assembly is shown in **Figure 5–2** from aft looking forward using inspection mirror.

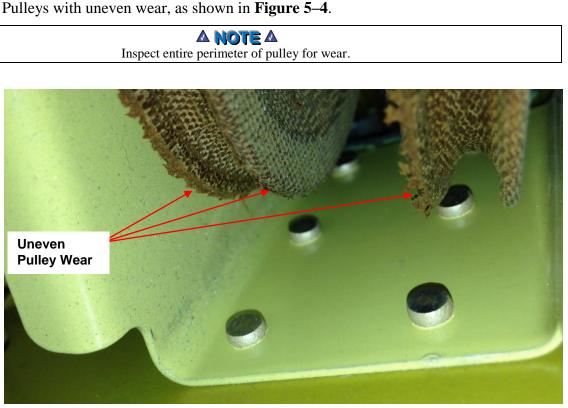
Figure 5-4: Inspection Items

1. Pulleys with uneven wear, as shown in Figure 5–4.

- 1. If the rudder pulley bracket does not meet the criteria above, order FSI-117 Rudder Pulley Bracket Assembly Replacement to be performed at or before the next Annual or 100 Hour Inspection.
- 2. If there is uneven wear (Condition 1), but the rudder pulley bracket meets the criteria in **Figure 5-6**, contact Quest Customer Service.
- 3. If there is cable damage or corrosion (Condition 2), but the rudder pulley bracket meets the criteria in **Figure 5-6**, order and replace rudder cables in accordance with the *KODIAK*[®]*100 Airplane Maintenance Manual*. Notify Quest Customer Service of findings.
- 4. If the cable guard is making contact with the pulleys or fuselage skin (Condition 3), modify or replace the cable guard so there is no contact between the cable guard and the pulleys or skin.

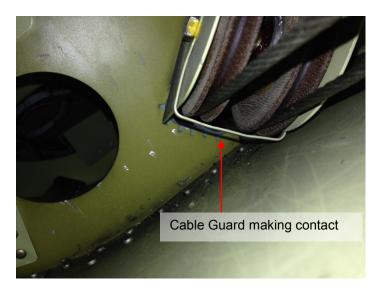
Figure 5-5: Cable Guard

3. Cable guard making contact with pulleys or fuselage skin as shown in Figure 5-5.
