**\*MANDATORY SERVICE BULLETIN\*****NUMBER:** SB11-15**REVISION:** 01**DATE:** 10/05/2011**SUBJECT:** CREW SEAT CHAIN PLATE INSPECTION**EFFECTIVITY:**

KODIAK 100 Series Aircraft Serial Numbers: 100-0001 through 100-0054

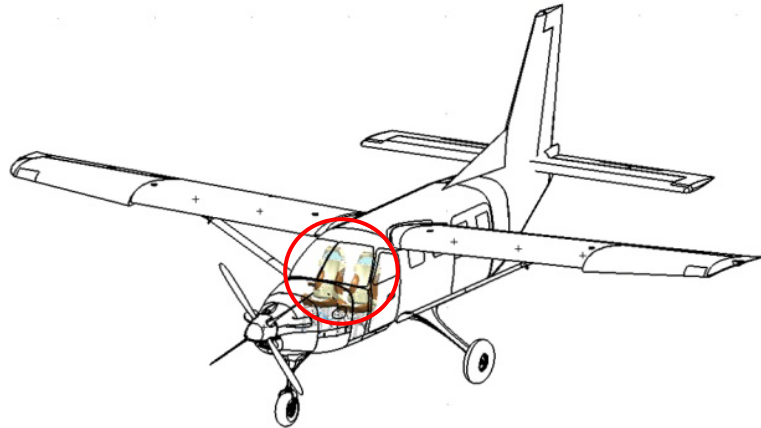
**Inspection Area:**

It has been found on one aircraft with over 1,000 flight hours that a crack has started to form around the nut on the crew seat chain plate, as shown on the next page. The damage is caused by users adjusting the seat height beyond its upper limit. (Adjustment arm located on the front of the crew seats between the occupant’s legs.) *Quest Aircraft Company* is mandating a one-time inspection of this bracket to bring special attention to mechanics. This inspection does not change or modify the inspection requirements as defined in the *KODIAK 100 Maintenance Manual, Chapter 5 “Time Limits/Maintenance Checks.”*

- 2.3. If brackets are incorrectly bent or cracks are found, the part(s) must be replaced. Contact Quest Aircraft Customer Service to order replacement parts.
  - 2.4. If no damage is found, continue to **Step #3**.
3. Repeat inspection procedure on the other crew seat.
4. Upon completion of all work instructions, record work completed in the appropriate *Kodiak 100 Log Books*.
