# \*MANDATORY SERVICE BULLETIN\*

NUMBER: SB-022 REVISION: B DATE: 10/30/2009

SUBJECT: PITOT STATIC SYSTEM; MANDATORY MODIFICATION

KODIAK 100 Series Aircraft, Serial Numbers 100-0001 through 100-0022

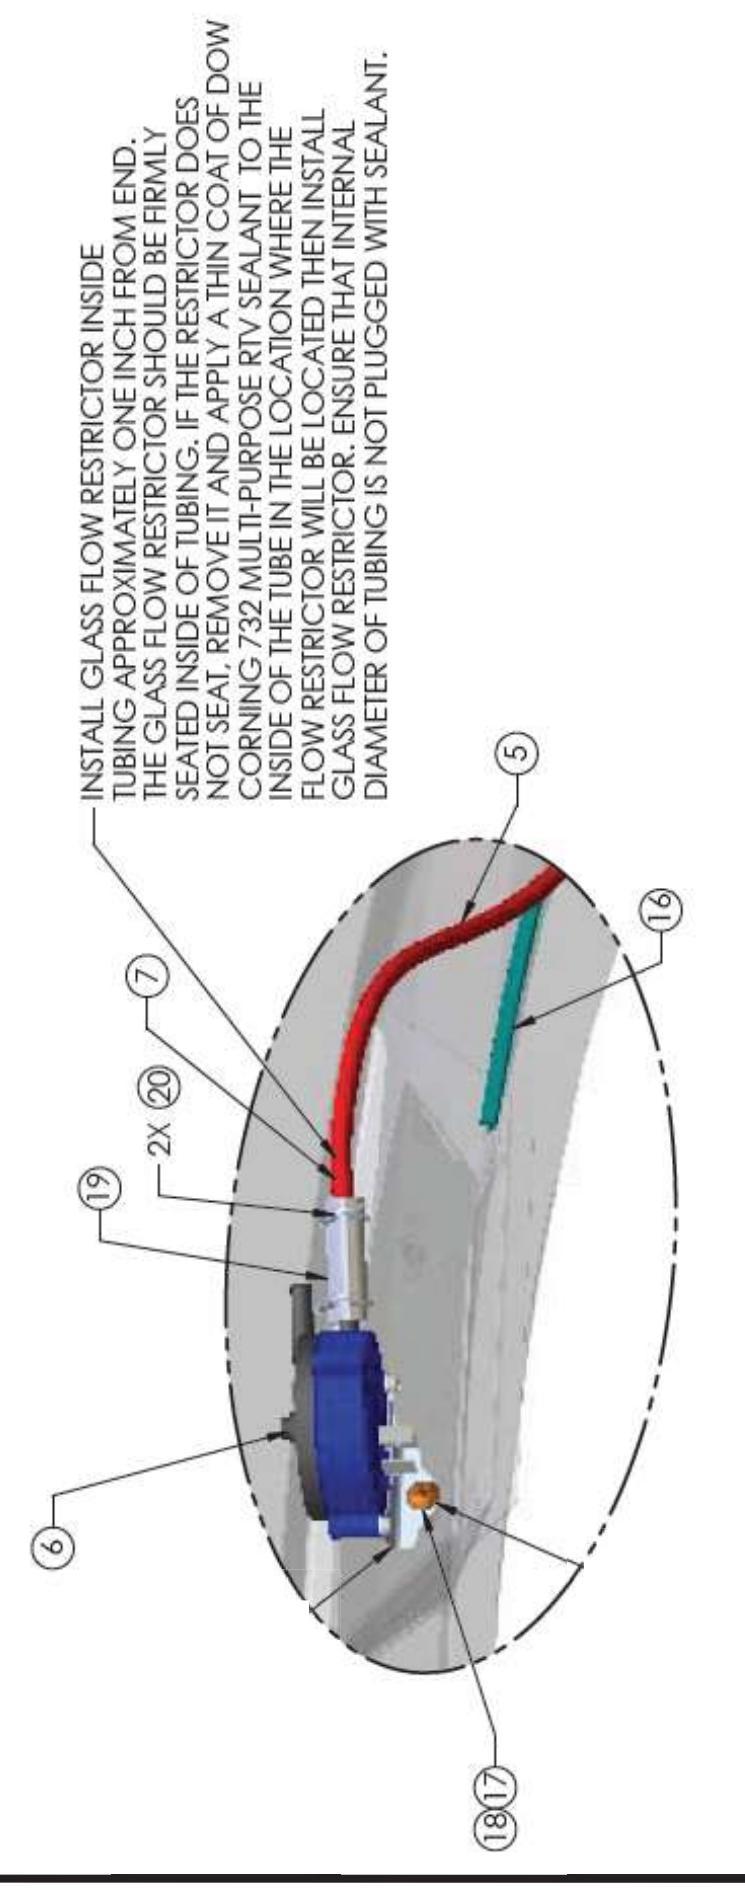
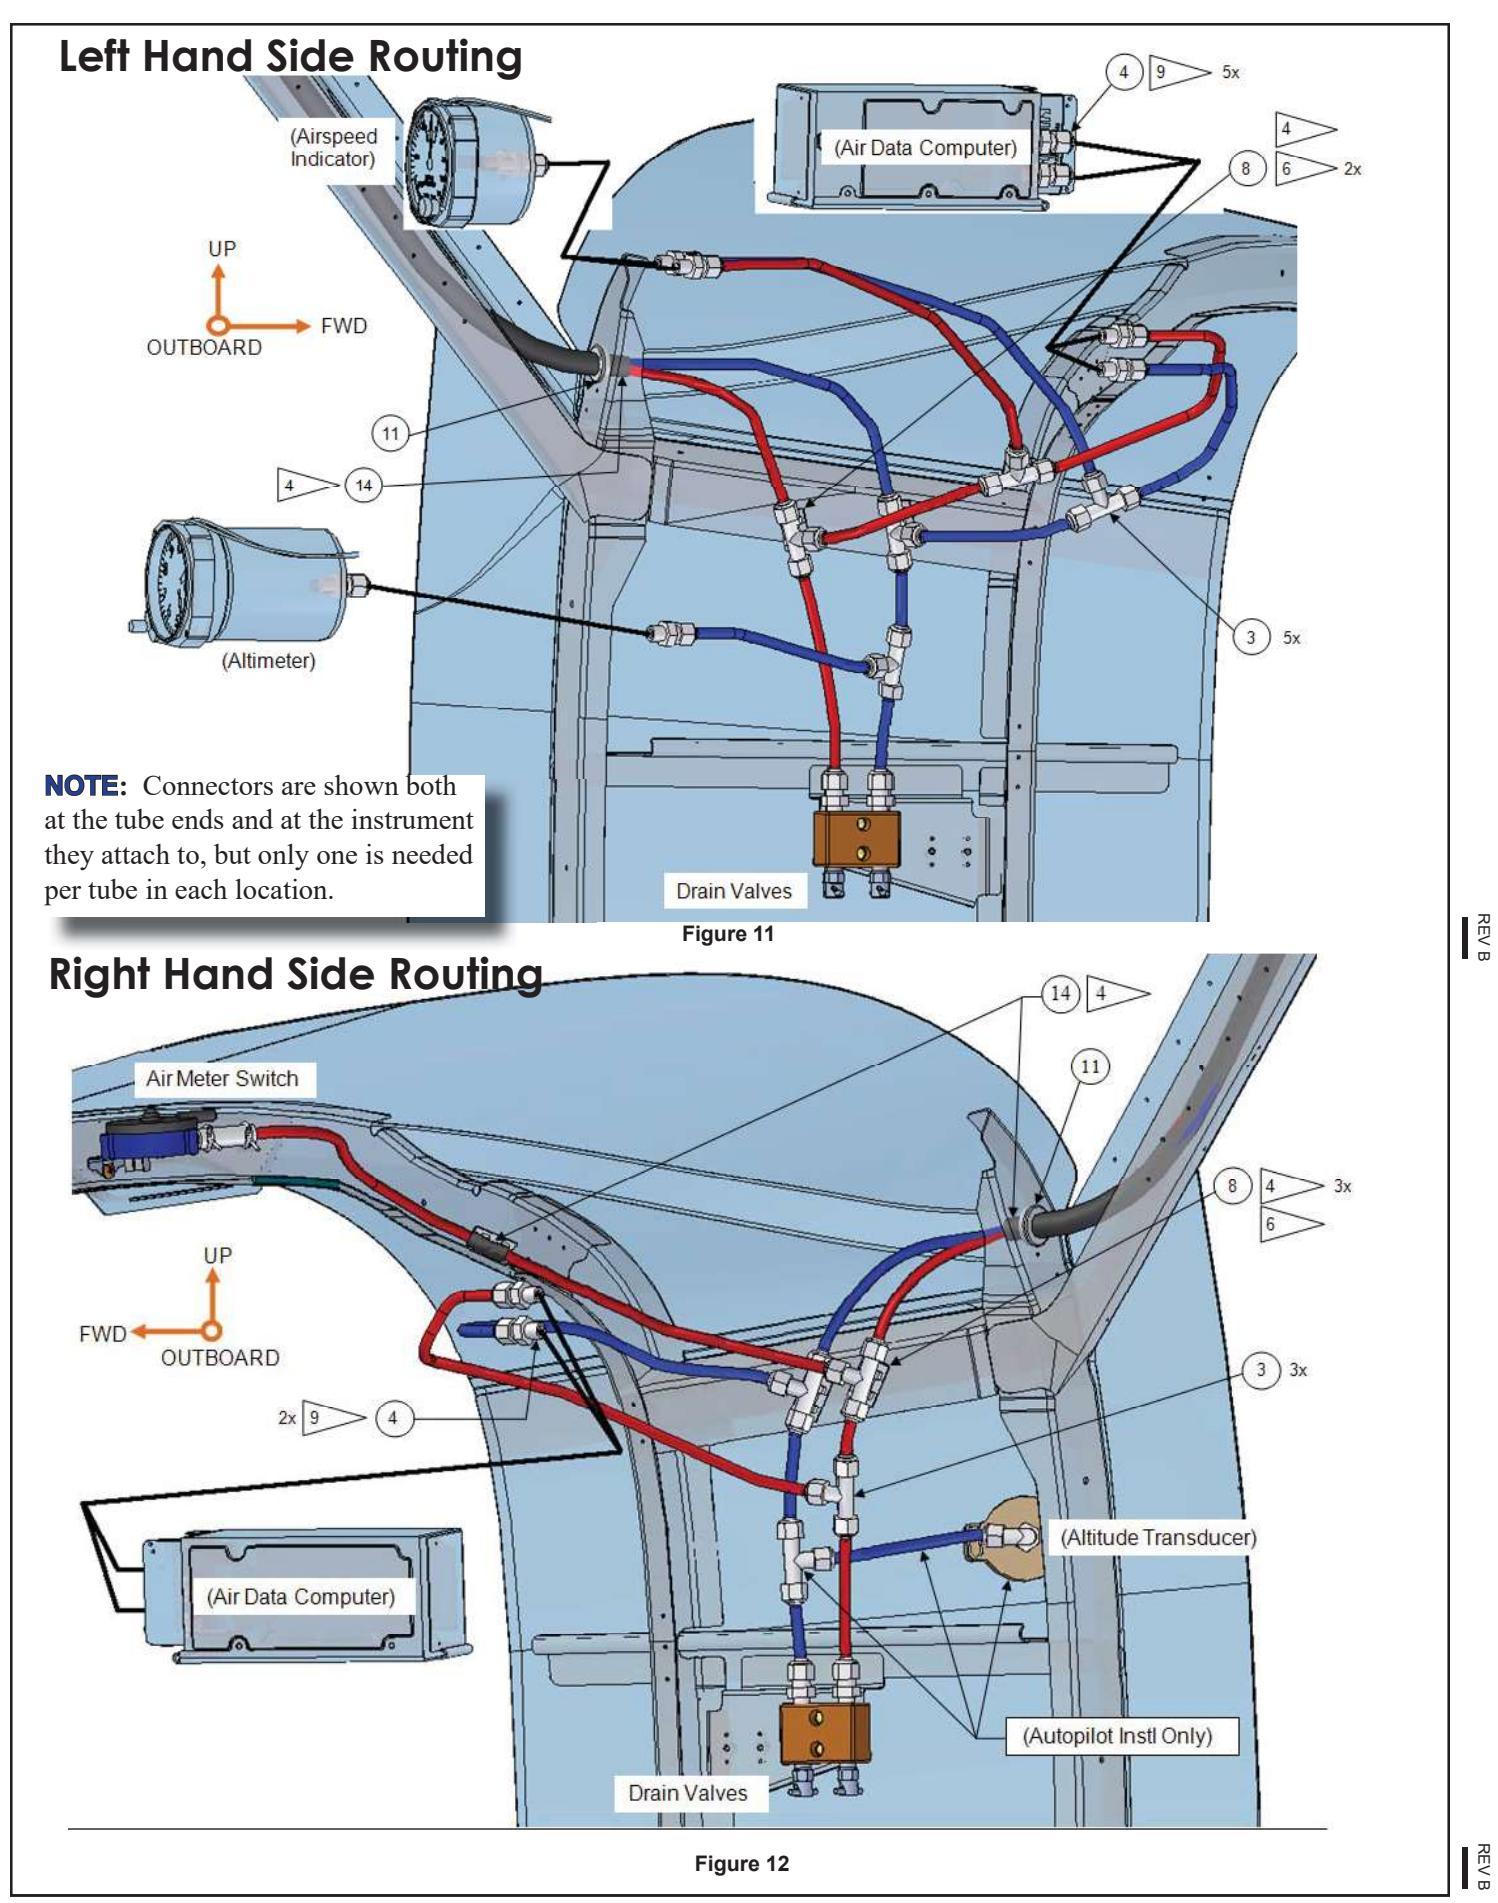
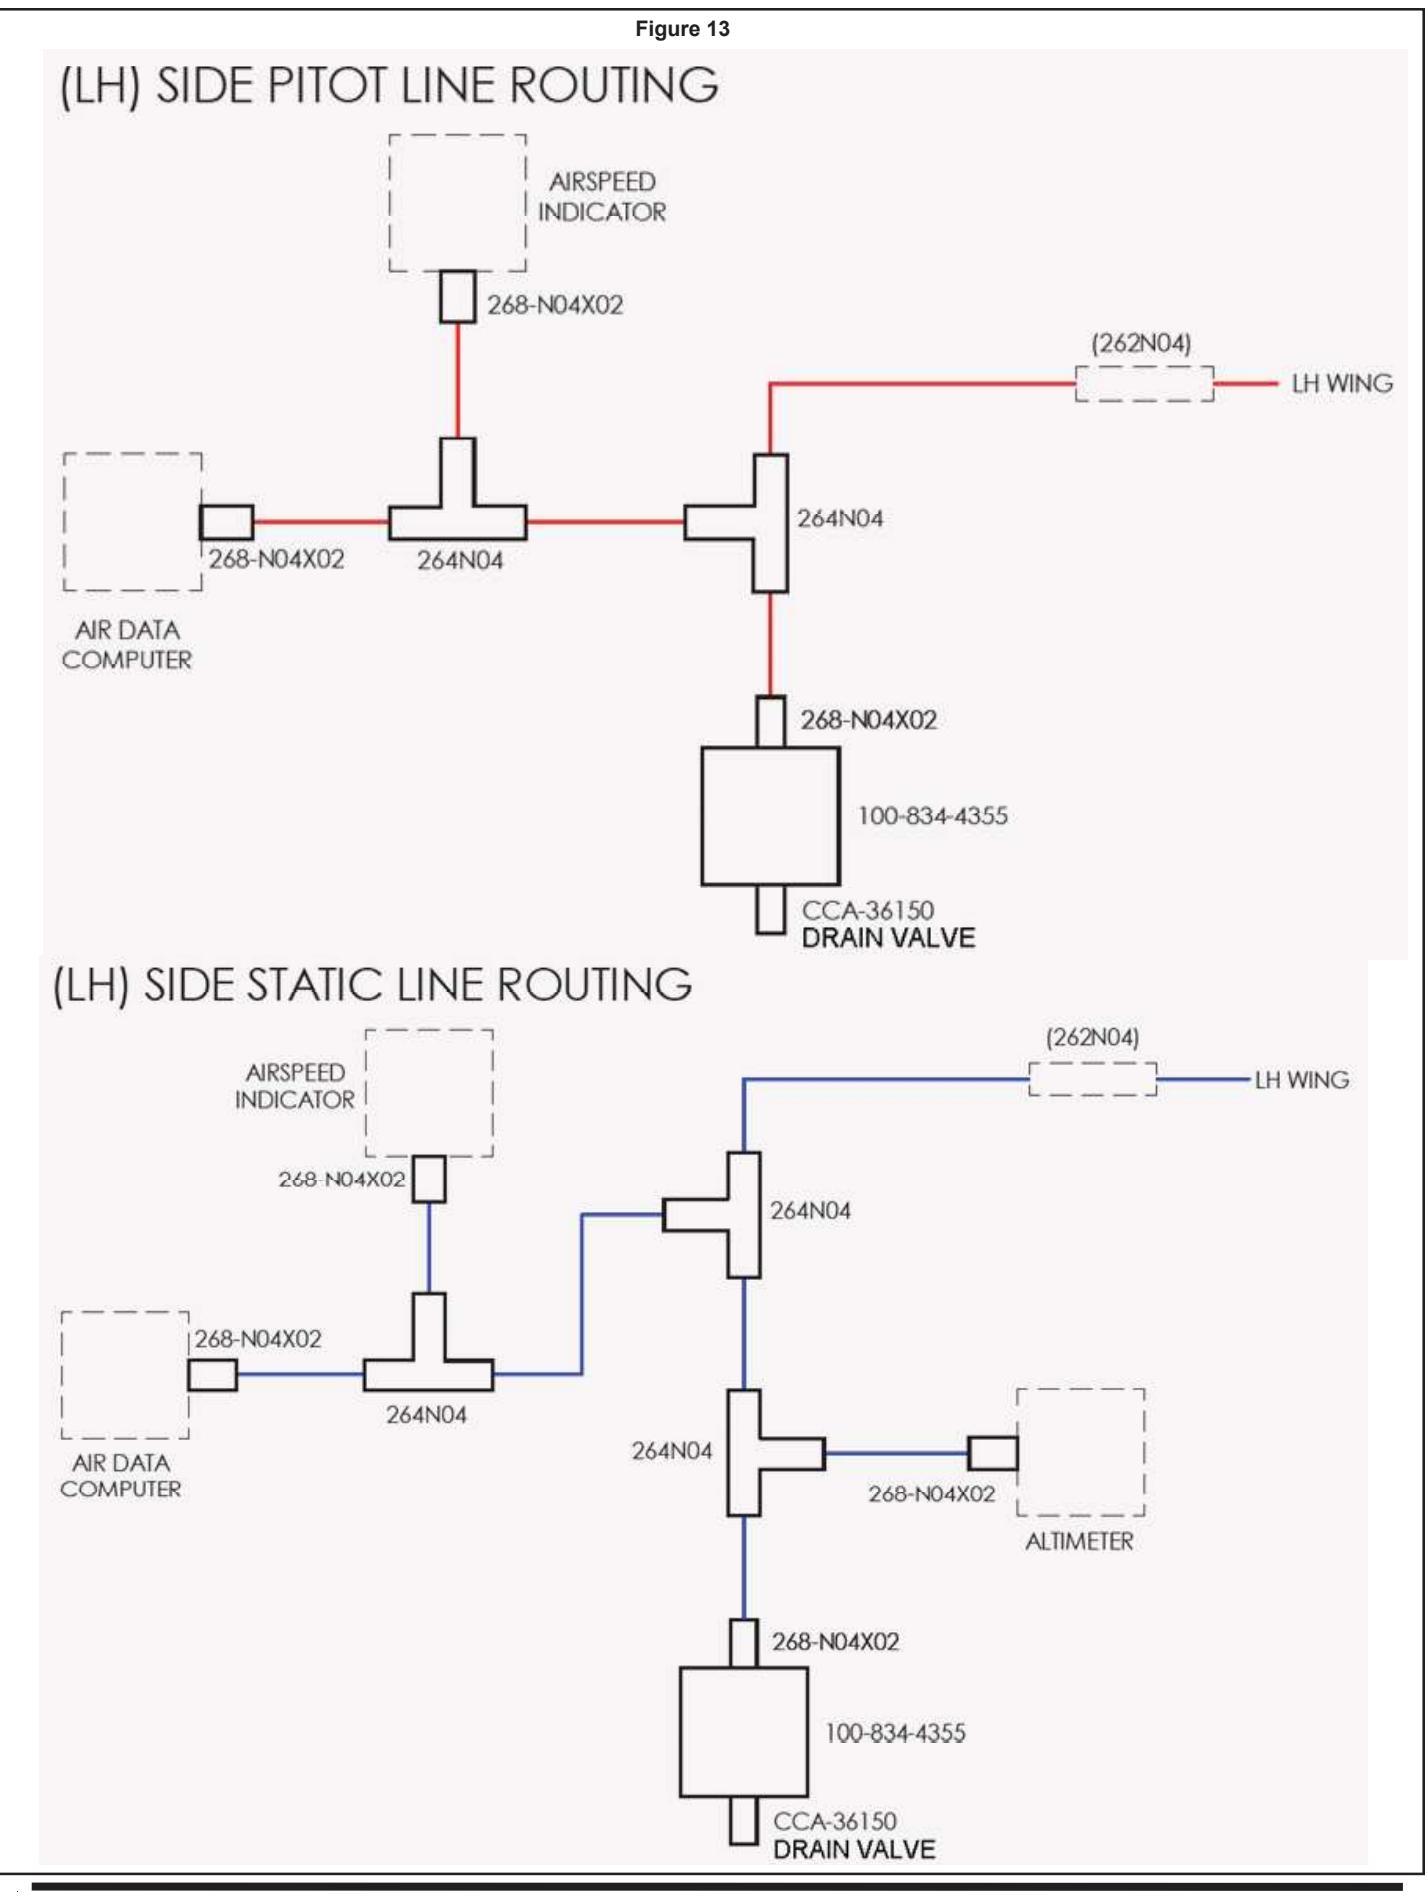
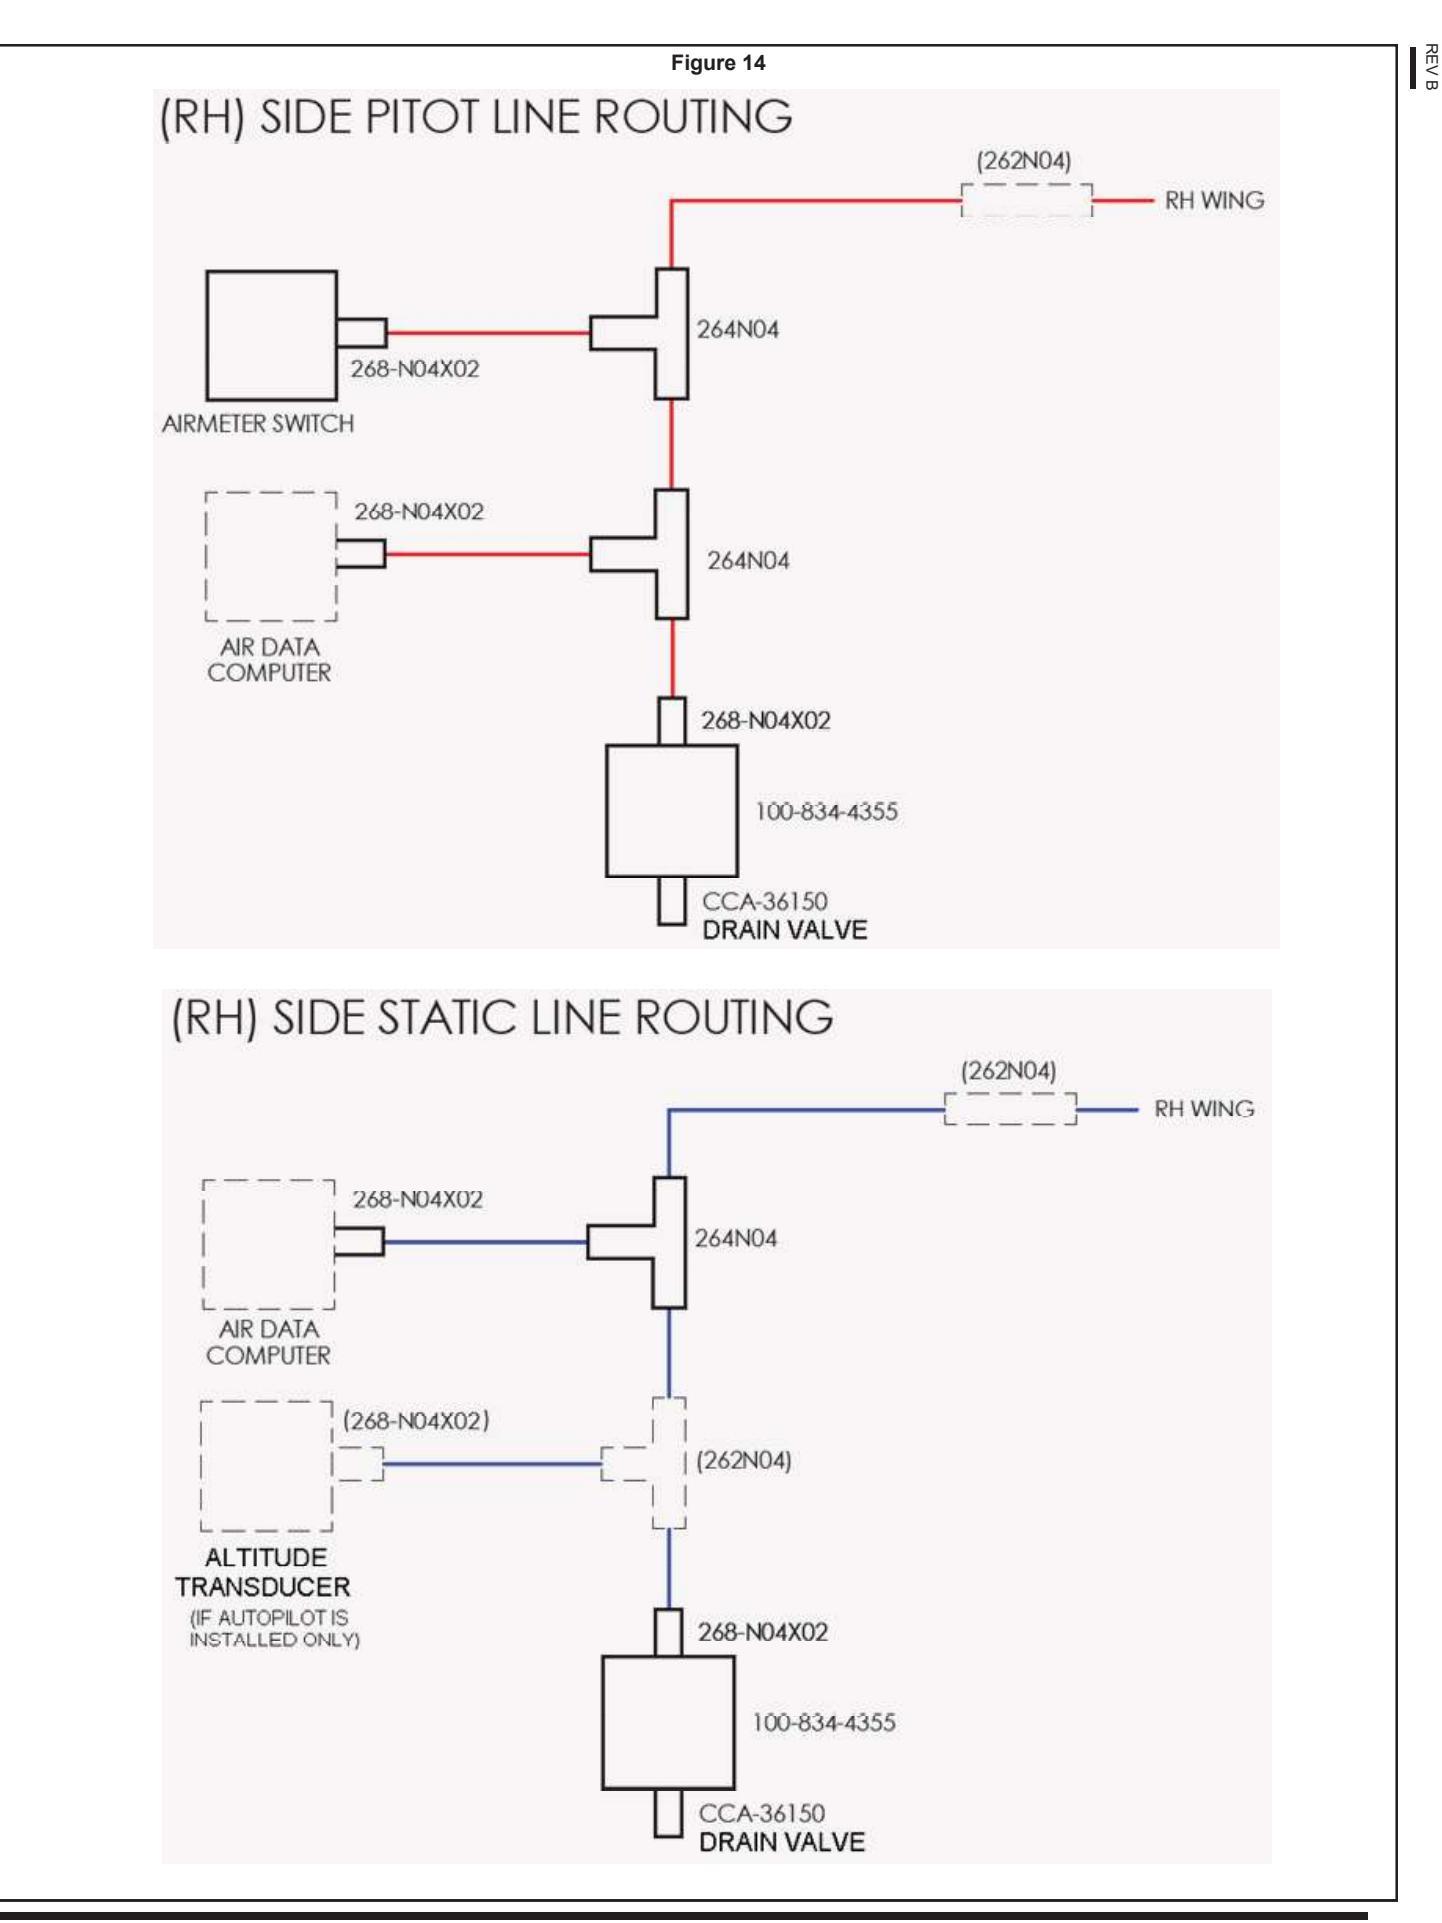
Pitot Static Low Point Mitigation		
Task		
14	Identify and remove the pitot static tubing indicated in Figure 9 (RH Side). Remove Center Garmin display and set aside. This will allow access to the Air Meter Switch. NOTE: Be sure to remove the insert stabilizers from the removed tubing and reuse at each connec- tion. NOTE: Be careful not to lose or damage the glass Flow Restricter within the tube near the Air Meter Switch (see Figure 10).	(RH) SIDE ROUTING SHOWN
15	A contract the pilot static tubing under the Left Hand dash per Figure 11 and Figure 13. NOTE: For a detailed schematic of routing see Figure 12.	
16	Reroute the pitot static tubing under the Right Hand dash per <b>Figure 10, Figure 12 and Figure 14</b> . <b>NOTE:</b> For a detailed schematic of routing see <b>Figure 14</b> .

17	Reinstall Center Garmin Display. Perform a pitot static system leak test as outlined in <b>Chapter 34</b> of the KODIAK 100 Maintenance Manual.	
18	Note the work performed in the KODIAK 100 Log Books.
