G1000 NXi Integrated Avionics System Line Maintenance Manual

Kodiak 100
System Software Version 2633.00 or later
2634.00 or later

This manual supports line maintenance of G1000 NXi systems installed and configured with System Software Versions 2633 and 2634.03 or later for the Kodiak 100.

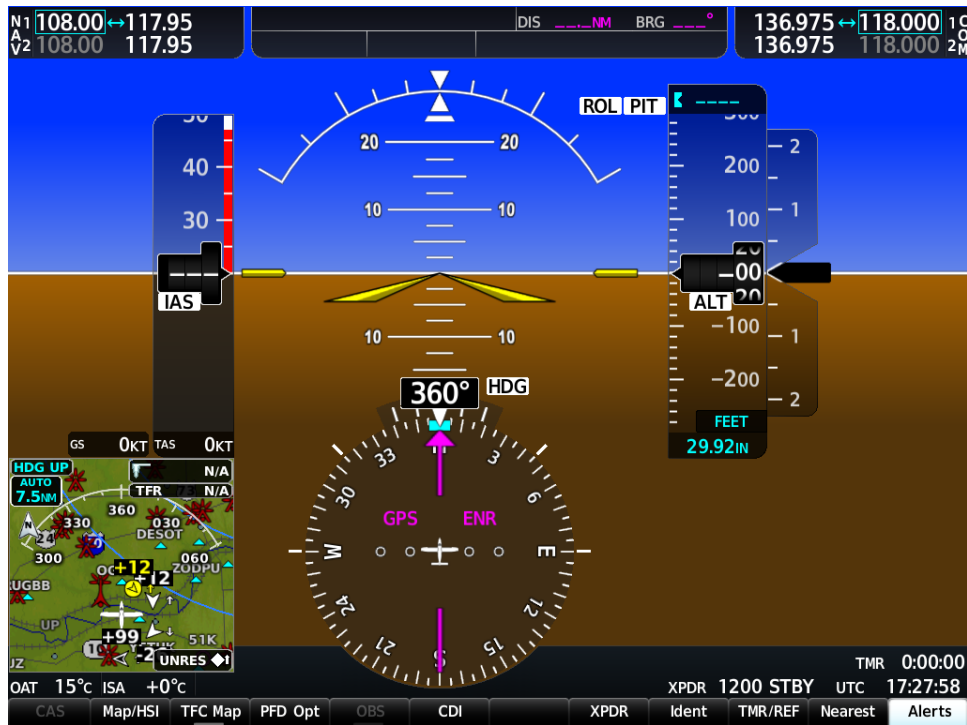
Figure 2-8. PFD Initialization (both PFDs)

When this information has been reviewed for currency (to ensure that no databases have expired), the pilot is prompted to continue. Pressing the ENT Key acknowledges this information and displays the Navigation Map (MAP) Page. When the system has acquired enough satellites to calculate a position, the aircraft's current position is shown on the Navigation Map Page.

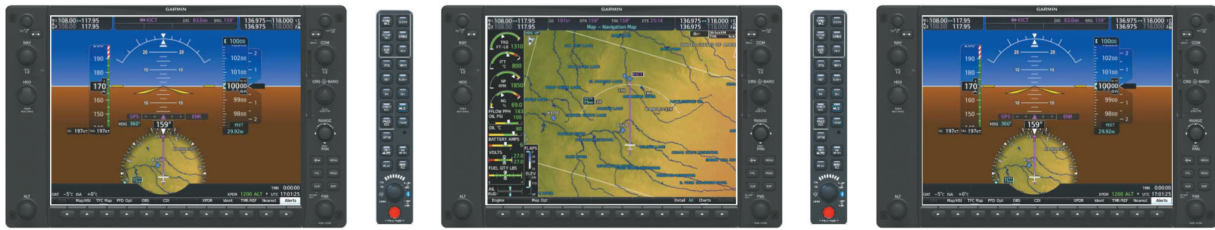
Figure 2-10. Normal Mode

In normal operating mode, the PFD presents graphical flight instrumentation (attitude, heading, airspeed, altitude, vertical speed), replacing the traditional flight instrument cluster. The MFD displays a full-color moving map with navigation information, while the left portion of the MFD is dedicated to the Engine Indication System (see [Figure 2-10](#)). Both displays offer control for COM and NAV frequency selection.

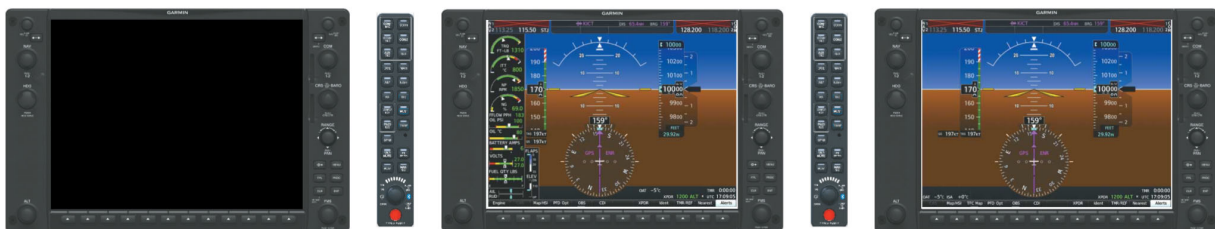
Figure 2-11. Reversionary Mode (Failed PFD)

In the event of a display failure, the system automatically switches to Reversionary (backup) mode. In Reversionary mode, all important flight information is presented on the remaining display in the same format as in normal mode (see [Figure 2-11](#)).

If a display fails, the appropriate interface between that display and the associated GIA is cut off. Thus, the GIA can no longer communicate with the remaining display. The NAV and COM functions provided to the failed display by the GIA are flagged as invalid on the remaining display. The system reverts to backup paths for the AHRS, ADC, Engine/Airframe Unit, and Transponder, as required. The change to backup paths is completely automated for all LRUs and no pilot action is required.

If the system fails to detect a display problem, Reversionary mode can be manually activated by pressing the red DISPLAY BACKUP button on the audio panel. Pressing this button again deactivates Reversionary Mode.

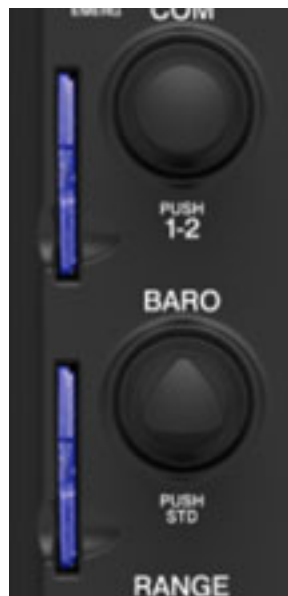
Figure 3-1. GDU SD Card Slots

The GDU data card slots are located in the upper right portion of the display bezels (see [Figure 3-1](#)). Each display bezel is equipped with two card slots. SD cards are used for aviation databases, system software, recording flight data, and storing electronic documents.

1. To Install an SD Card:
 - a) Insert the SD card into the SD card slot.
 - b) Push the card in until the spring latch engages.
 - c) The front of the card should remain flush with the face of the display bezel.
2. To Remove an SD Card:
 - a) Gently press on the SD card.
 - b) The spring latch should release and eject the card.

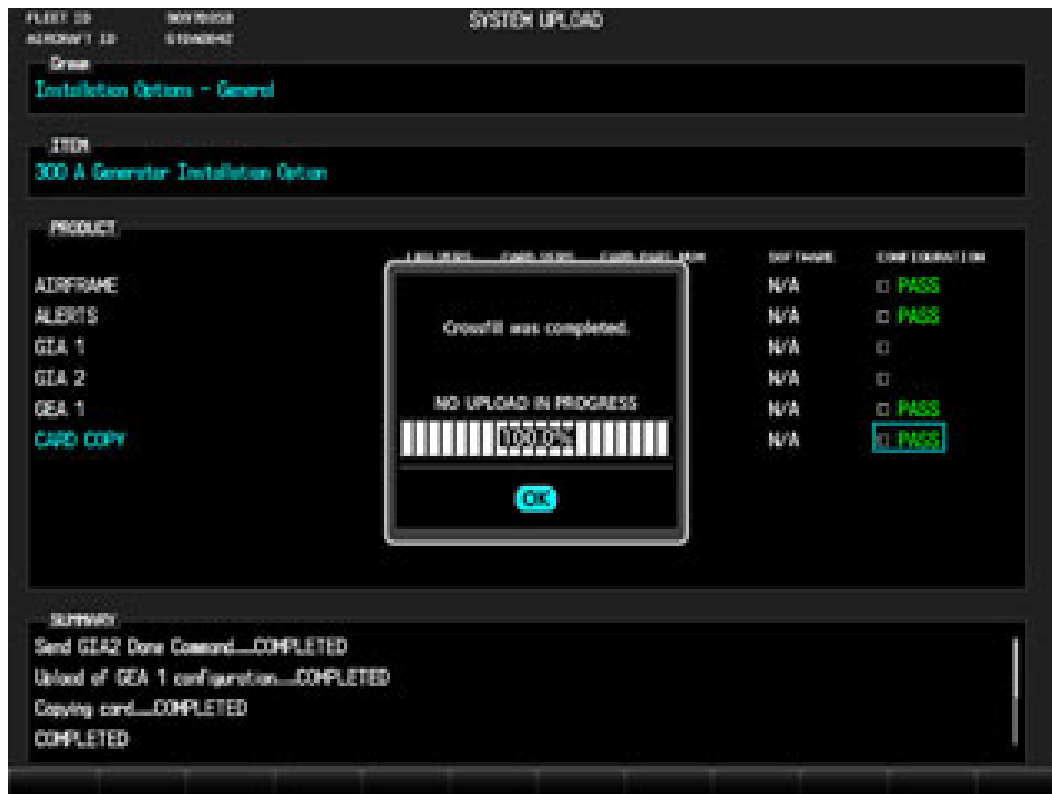
Figure 3-15. Crossfill Monitor

While the Crossfill Monitor is waiting for crossfill to complete, a progress bar displays the percentage of the 10-minute timeout that has elapsed. This bar does not display the crossfill progress. When crossfill is complete, the bar will be set to 100%, the Crossfill Monitor will display a message to the technician indicating the upload is complete, and the OK button will appear, concluding the upload process.

After a configuration file upload to an MFD or PFD is complete, it has only been verified on PFD1, and not on any other device. If the technician powers down the devices before the configuration has been sent to the other devices on the crossfill network, it is possible the other devices may not have received the entire configuration. When these devices are powered on with missing or invalid configuration, they may revert to a default, safe configuration, and then that new configuration will be cross filled to the other devices (including the original device that has the correct configuration), erasing the uploaded configuration. The Crossfill Monitoring System prevents that from happening by waiting until crossfill has completed to declare the upload complete, at which point it is safe to power down the devices.

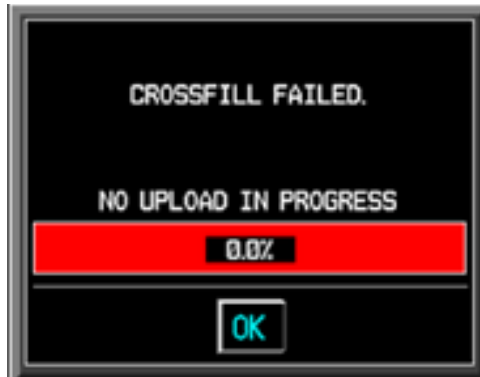
Figure 3-17. Crossfill Failed

The Crossfill Monitor immediately fails if it detects that a configured LRU (PFD, MFD) is not online. This is because an offline device could cause the problem the monitoring system was meant to prevent if it did not receive the configuration, or if it received only partial configuration.

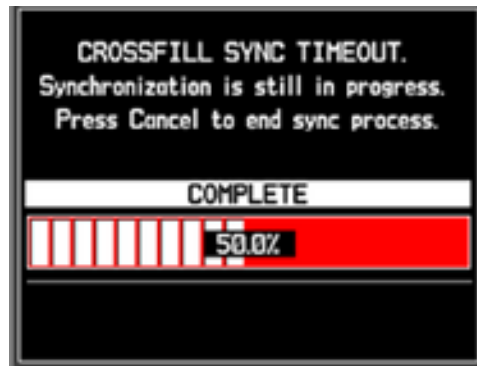
Figure 3-19. Crossfill Sync Timeout

The Crossfill Monitor waits indefinitely for crossfill to complete, but after 10 minutes it displays a message advising the technician that something may be wrong.

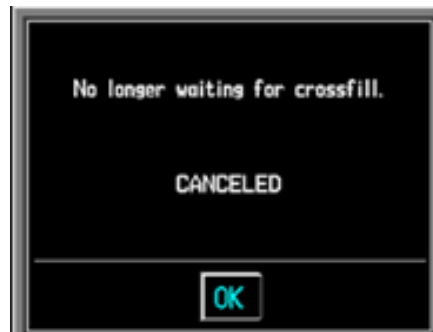
Figure 3-21. No Longer Waiting for Crossfill

Even though 'timeout' has occurred, crossfill still proceeds normally, and if the Crossfill Monitor detects the network has synced all of the 'config' tags, it will still show a completion message, even after timeout. This message will only be displayed if the user has not yet canceled. Crossfill will still be ongoing even after the user cancels, though it will no longer be monitored.

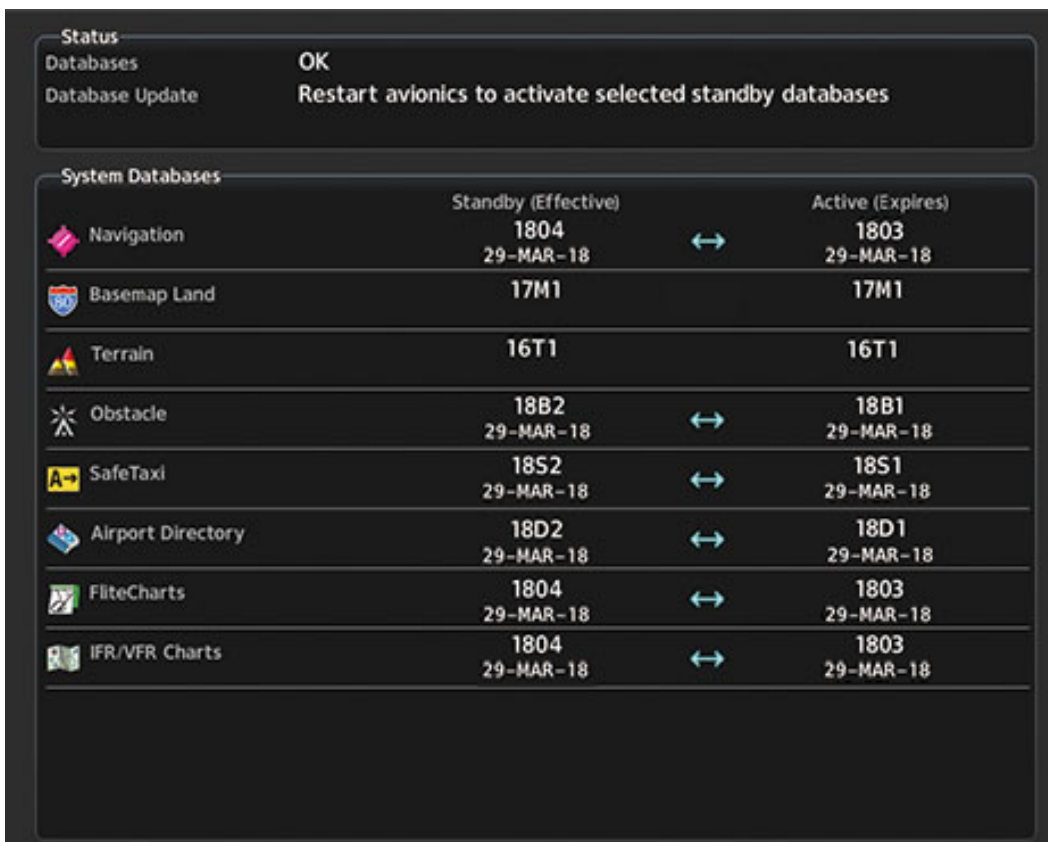
1. With the system OFF, remove an SD Card from the top SD card slot of the MFD.
2. Download and install the databases on an SD card.
3. Put the SD Card in the top SD card slot of the MFD.
4. Turn the system ON.
5. Press the ENT Key or the right-most softkey on MFD display to acknowledge the startup screen.
6. Turn the large FMS Knob and select Aux.
7. Turn the small FMS Knob and select Databases.
8. Monitor the Sync Status on the 'Aux-Databases' Page. Wait for all databases to complete syncing, indicated by 'Sync Complete' being displayed. A cyan double arrow will appear between the Standby and Active columns to show which Standby databases will be transferred to Active at the next power cycle.

Status		OK	
Databases		Restart avionics to activate selected standby databases	
System Databases			
	Standby (Effective)		Active (Expires)

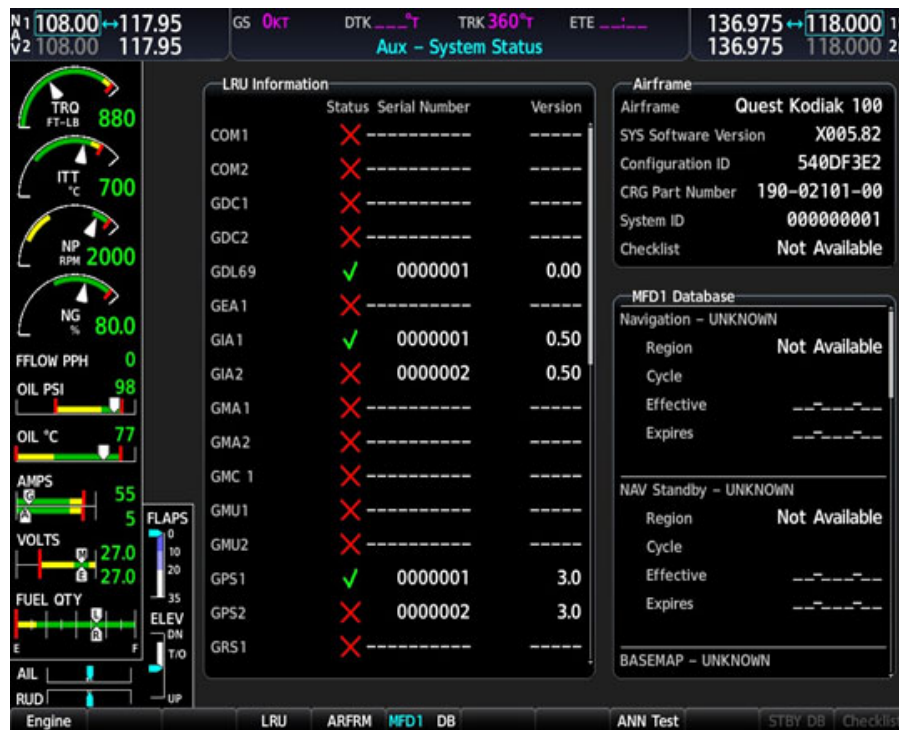
Figure 4-3. System Status Page

The System Status Page on the MFD provides LRU health status by means of a green check mark or red X indication (see [Figure 4-3](#)). Software versions are listed for installed LRUs, along with other database versions and dates. If a red X is shown for an LRU, refer to the associated troubleshooting information in [Section 4.7](#).

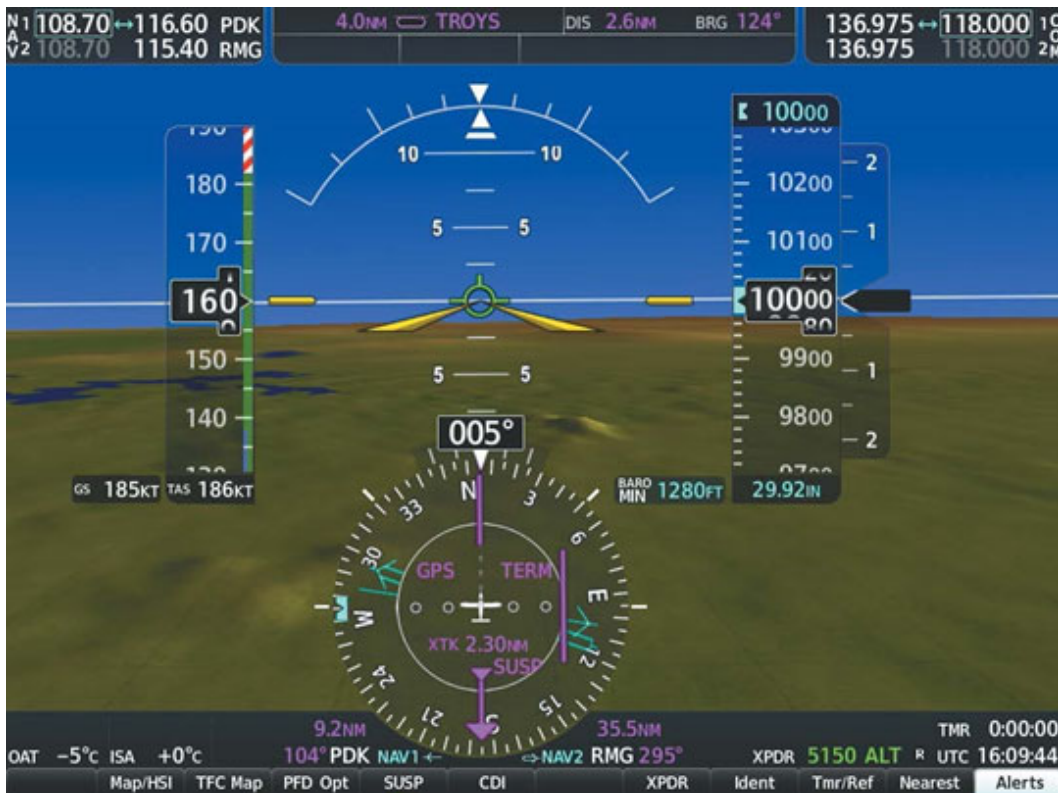
Figure 4-4. SVT View on the PFD

The optional Synthetic Vision Technology (SVT) is a visual enhancement to the G1000 NXi. SVT depicts a forward-looking attitude display of the topography immediately in front of the aircraft. The field of view is 30 degrees to the left and 35 degrees to the right. SVT information is shown on the Primary Flight Display (PFD), or on the Multifunction Display (MFD) in Reversionary Mode.

The depicted imagery is derived from the aircraft attitude, heading, GPS three dimensional position, and a 4.9 arc-second database of terrain, obstacles, and other relevant features. The terrain data resolution of 4.9 arc-seconds, meaning the terrain elevation contours are stored in squares measuring 4.9 arc-seconds on each side, is required for the operation of SVT.

SVT is intended to be used with traditional attitude, heading, obstacle, terrain, and traffic inputs. SVT is disabled when valid attitude or heading data is not available for the display. In case of invalid SVT data, the PFD display reverts to the standard blue-over-brown attitude display.

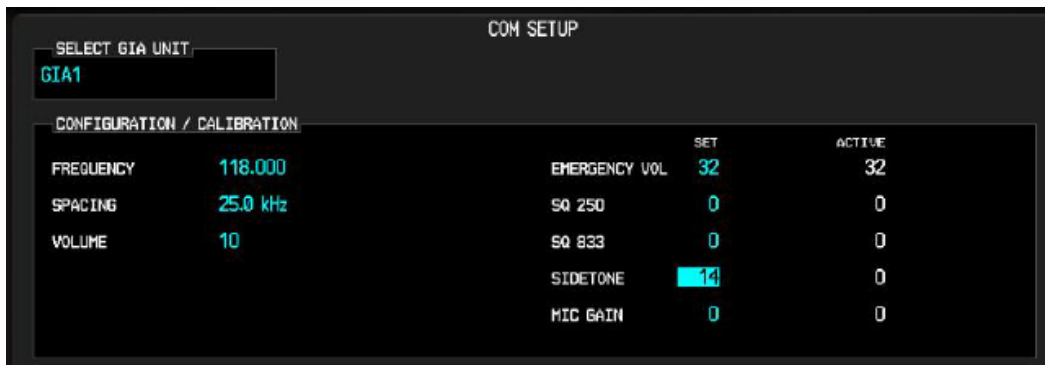
Figure 4-6. COM Setup Page Sidetone Adjustment

3. A window showing the SIDETONE setting is displayed (see [Figure 4-6](#)).
4. Check the sidetone setting and adjust as necessary. The range is -100 to +100.

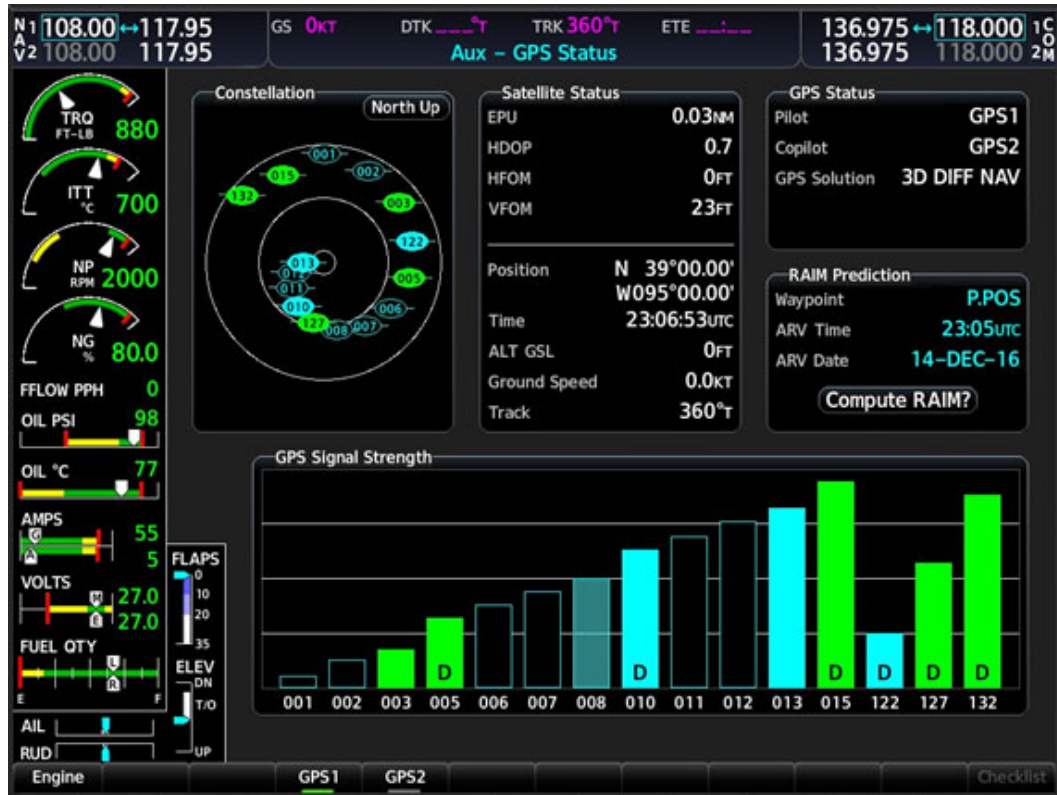
Figure 4-9. GPS Receiver Information

Each GIA contains a GPS receiver. Information collected by the specified receiver (GPS1 for GIA1 or GPS2 for GIA2) can be viewed on the GPS1 or GPS2 Status pane (see [Figure 4-9](#)).

These GPS sensor annunciators are most often seen after system start when one GPS receiver has acquired satellites before the other, or one of the GPS receivers has not yet acquired an SBAS (Satellite Based Augmentation System) signal. While the aircraft is on the ground, the SBAS signal might be blocked by obstructions causing one GPS receiver to have difficulty acquiring a good signal. Also, while airborne, turning the aircraft might result in one of the GPS receivers temporarily losing the SBAS signal. If the sensor annunciator persists, check for a system failure message by touching the MSG Button on Touchscreen Controller. If no failure message exists, check the GPS Status Screen and compare the information for GPS1 and GPS2. Discrepancies might indicate a problem.

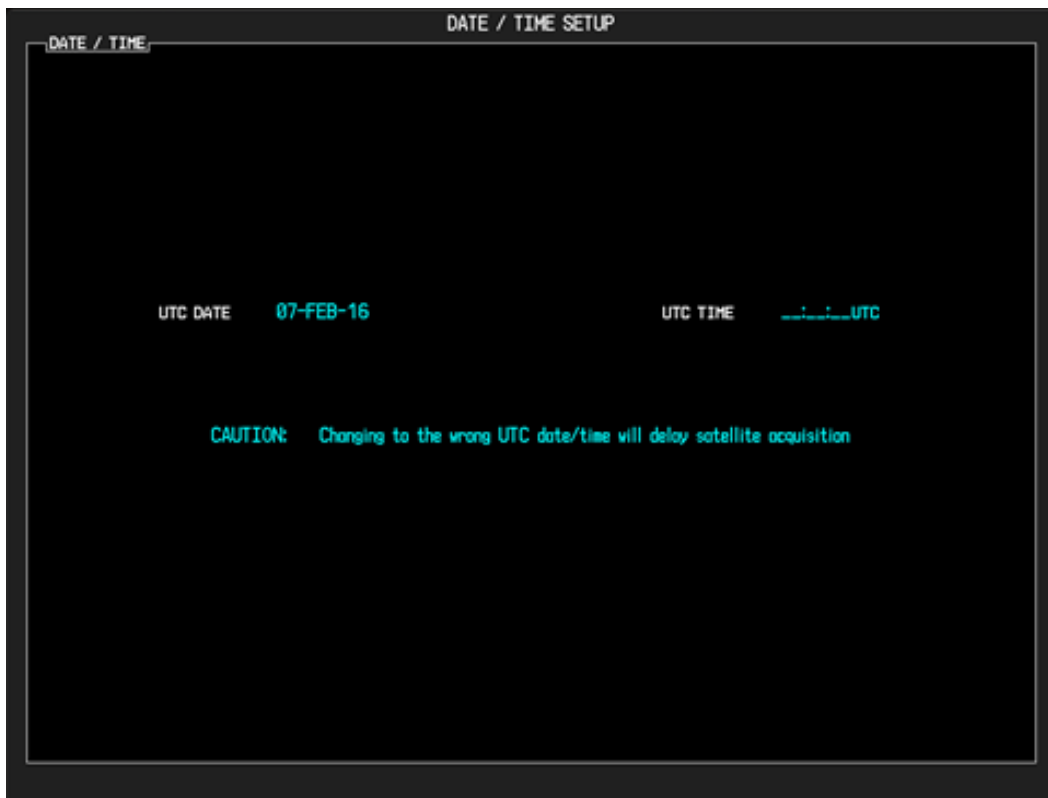
Figure 4-10. Date / Time Setup Page

1. Make sure that no cell phone or device using cell phone technology is turned on in the cable, even in a monitoring state.
2. Check for possible external interference to the GPS receivers by selecting the GPS status page on the Touchscreen Controller and check the GPS strength bars on both GPS receivers. If the signal strength level is erratic, or if they disappear and reappear rapidly, or if they switch between a solid and hollow bar frequently, there is possibly an external device interfering with the GPS receivers. Turn off any devices that radiate a signal in the local area or move the aircraft to another location to see if the interference is removed.
3. Check the date and time shown on the Date/Time Setup page and enter the correct values, if necessary (see [Figure 4-10](#)).

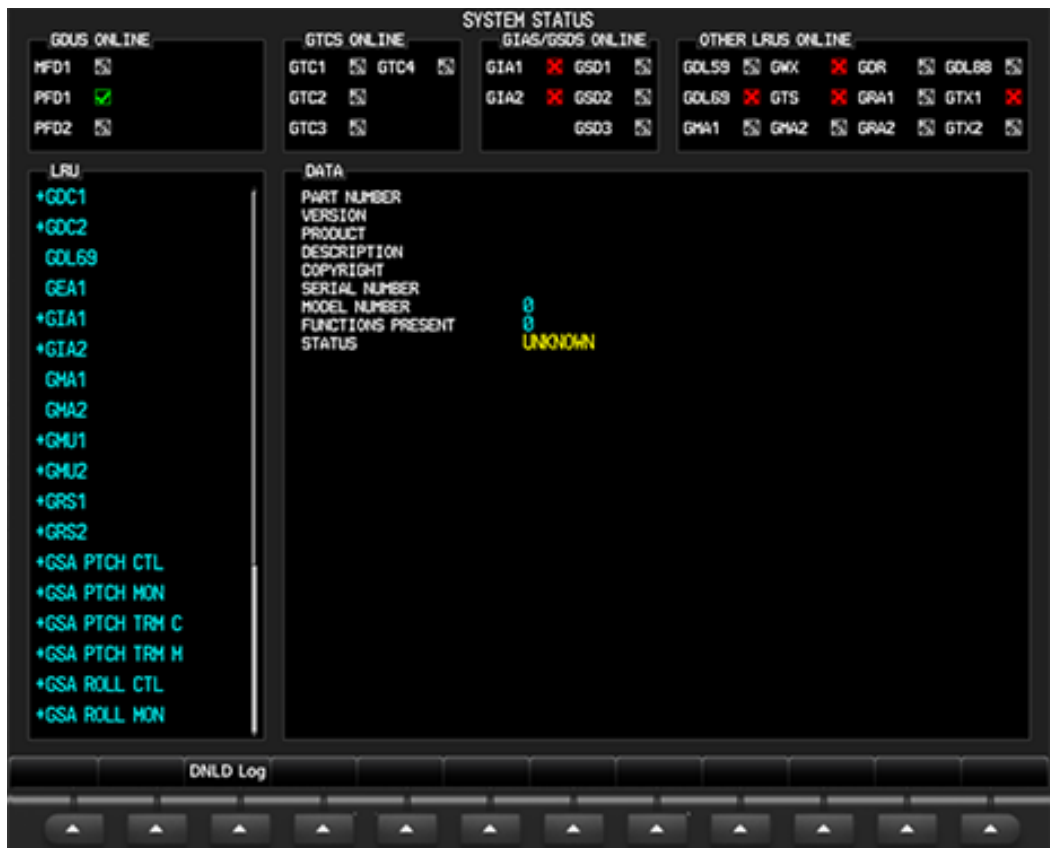
Figure 4-18. System Status Page (Configuration Mode)

1. Place an SD card into the top slot of PFD1.
2. Start the system in configuration mode.

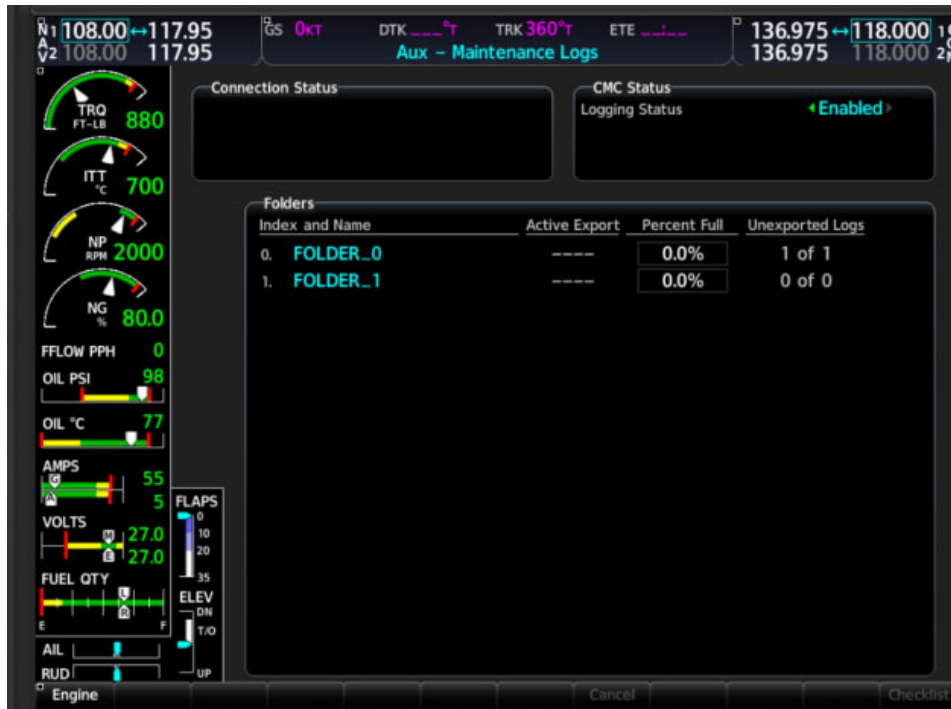
Figure 4-22. MFD Aux-Maintenance Logs page

1. Insert an SD card into the top slot of the MFD.
2. On the MFD, navigate to the Aux->Maintenance Logs page.

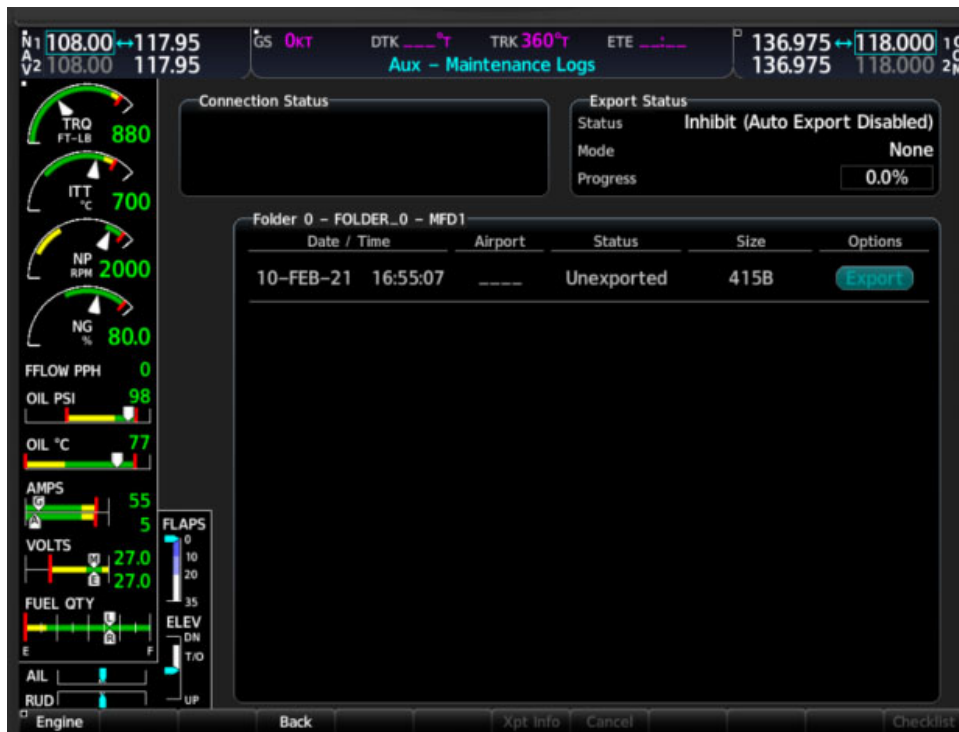
Figure 4-23. File Selected for Export

3. Select the folder for export.

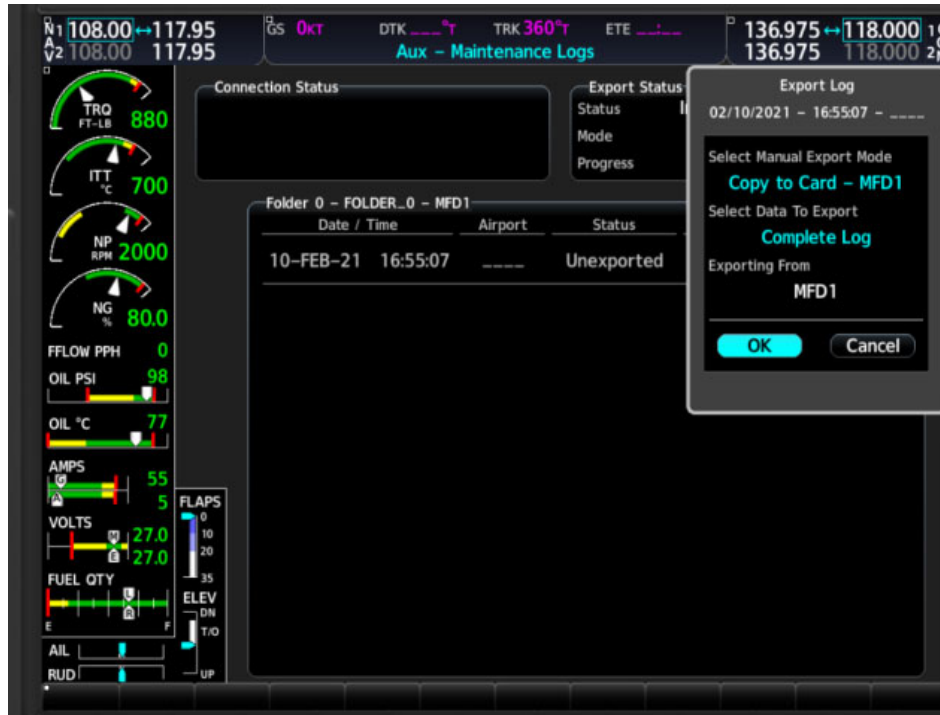
Figure 4-24. Selected File Exporting

4. Press the Export Button, and then press OK.

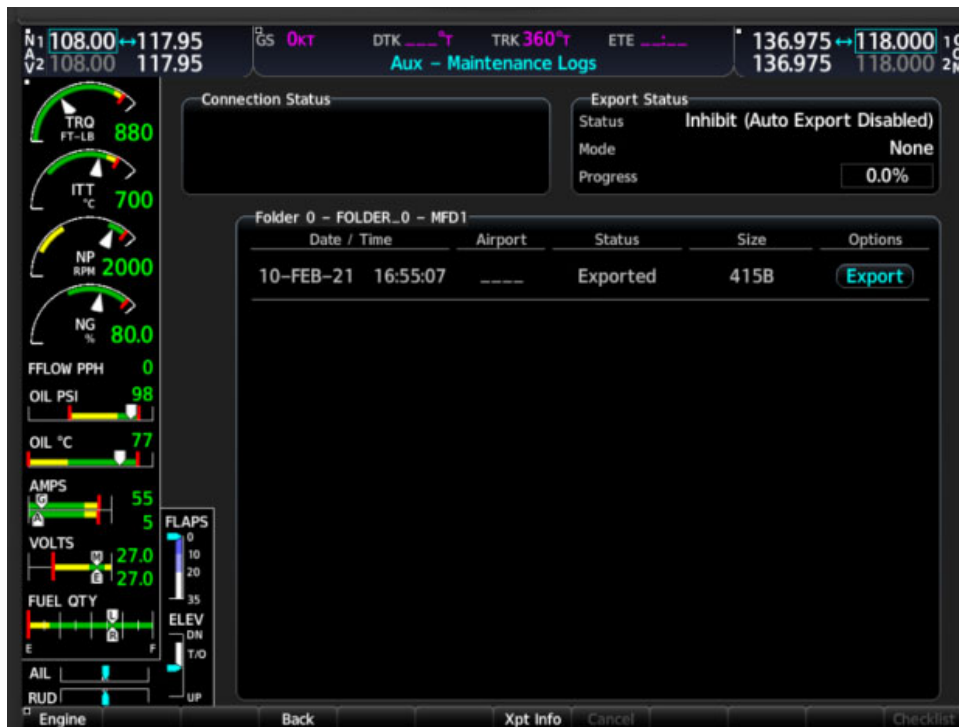
Figure 4-25. Folder Exported

5. Once the Status indicates 'Exported', the file will be on the SD card in a folder with the same name as the log folder (in this case, FOLDER_0).

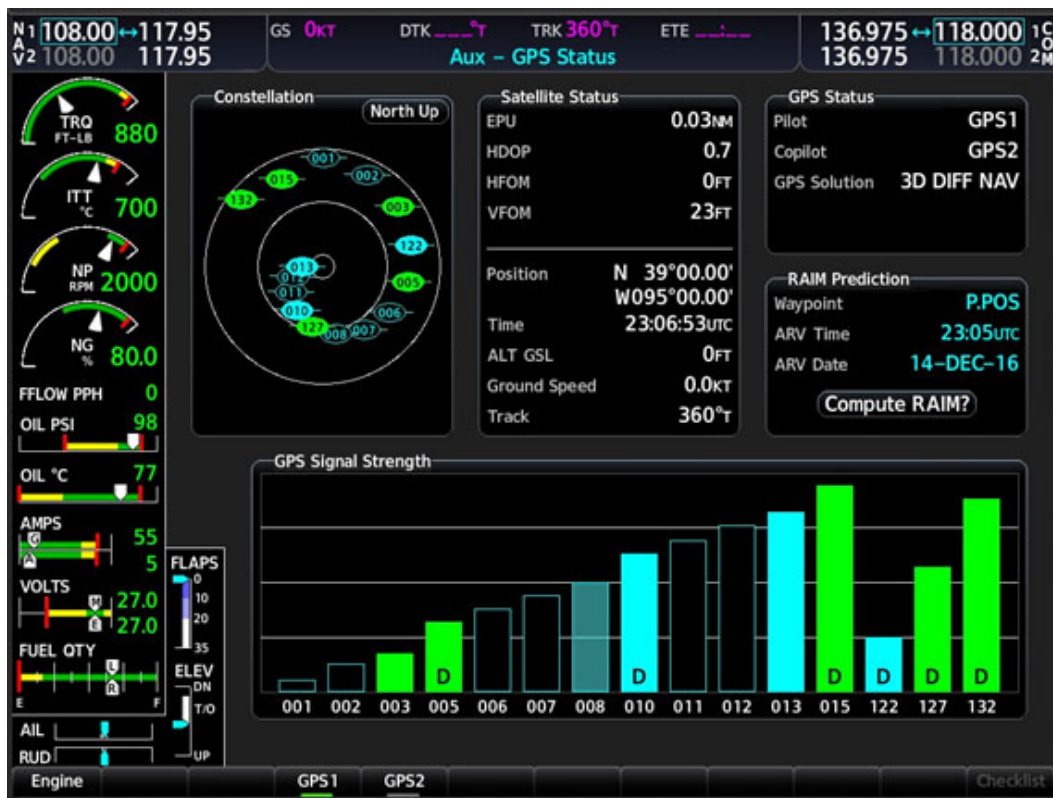
Figure 7-2. Aux - GPS Status Page (MFD)

The GIA units should normally acquire a GPS navigation solution within 5 to 10 minutes of startup, provided the aircraft is outside (or indoors with a GPS repeater). Select the Aux - GPS Status page on the MFD. Two softkeys on the bottom of the display allow the user to toggle between GPS 1 and GPS 2. Make sure both receivers show 3D DIFF NAV on the MFD.

1. Monitor GPS signal strength bars on the Aux-GPS Status page (see [Figure 7-2](#)).
2. On the PFD, ensure the CDI is set to GPS. If it is not, press the CDI softkey until GPS ENR is displayed.

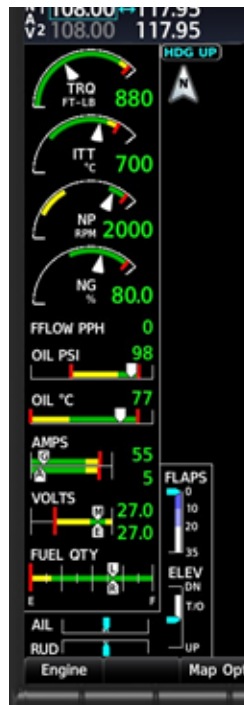
Figure 7-4. Engine Indication System-MFD

1. The system Engine Indication System (EIS) displays critical engine, electrical, fuel, and other system parameters on the left side of the Multi Function Display (MFD) during normal operations.

2. The Kodiak 100 EIS instrument types include vertical slider gauges, horizontal bar indicators, digital displays, and slide bars. Green bands and displays indicate normal ranges of operation; amber and red bands and displays indicate caution and warning, respectively. When unsafe operating conditions occur, displays, pointers, and labels may change color and flash corresponding to the level of the condition. If sensor data to an instrument becomes invalid or unavailable, a red X is shown across the instrument.

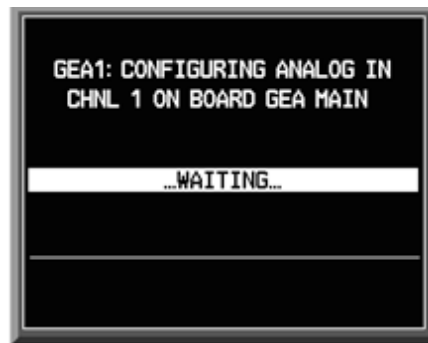
Figure 7-9. Configuration Verification Processing

- e) Press the ENT Key to accept the CALIBRATION OFFSET value, the instantaneous CALIBRATION OFFSET value will be stored as the CURRENT OFFSET.
- f) The G1000 NXi will now recheck the GEA configuration (this may take several minutes). During this time the box shown in [Figure 7-9](#) will be displayed. Do not perform any actions until this is complete.

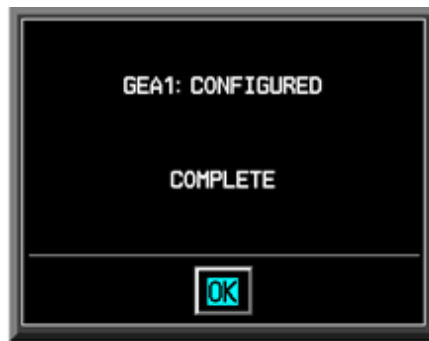
Figure 7-10. Configured Confirmation Box

- g) When the configuration is completed, press the ENT Key to confirm.

- h) Once verification is complete, the CURRENT CORRECTED VALUE should be zero, within a range of fluctuation that is equal to or less than noted before calibration. If this is the case the calibration has been successfully completed.

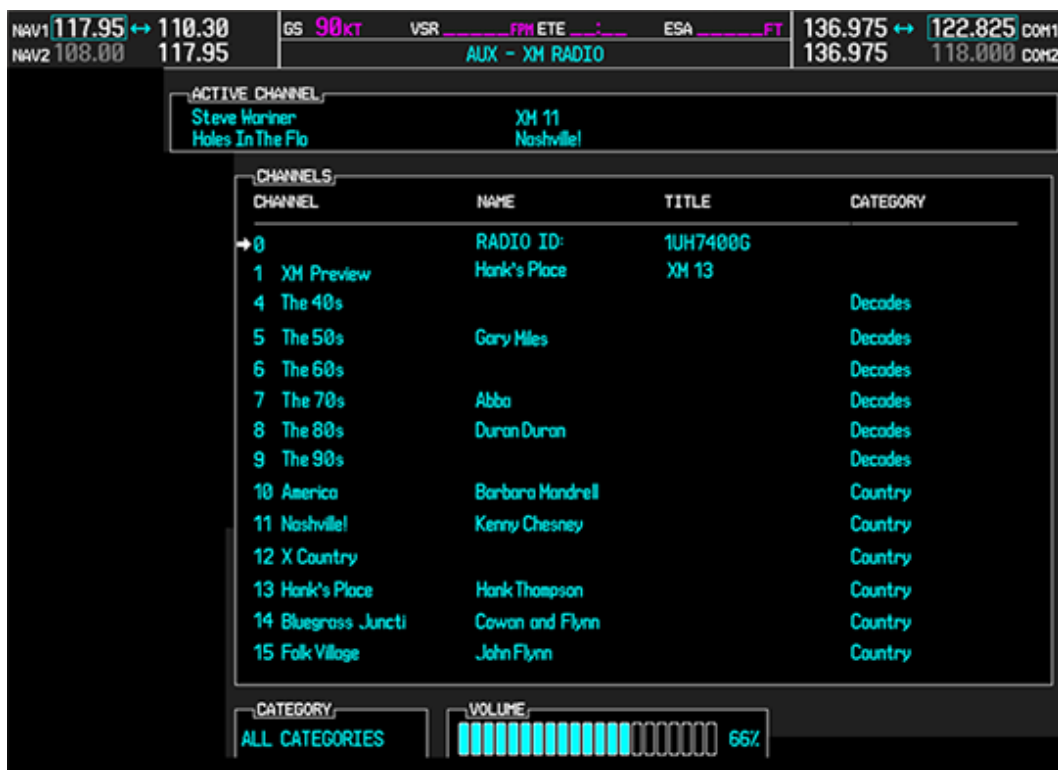
Figure 7-11. XM Radio Page

1. Select the AUX - XM RADIO page on the MFD.
2. Using the channel control located in the cabin, make sure you can increment and decrement the channels (the white arrow to the left of the channel list indicates the currently selected channel). Select channel 1 when complete.
3. Using the volume control located in the cabin, make sure you can increase and decrease the XM radio volume (the volume bar at the bottom of the screen will show changes to the volume level).
4. Set the volume to the mid position when done.
5. Plug a set of headphones into one of the passenger stations and make sure you can hear the XM radio playing in both left and right channels. The volume level may be adjusted to a comfortable level at this point.
6. Plug a set of headphones into one of the pilot station and make sure you can hear the XM radio playing in both left and right channels.

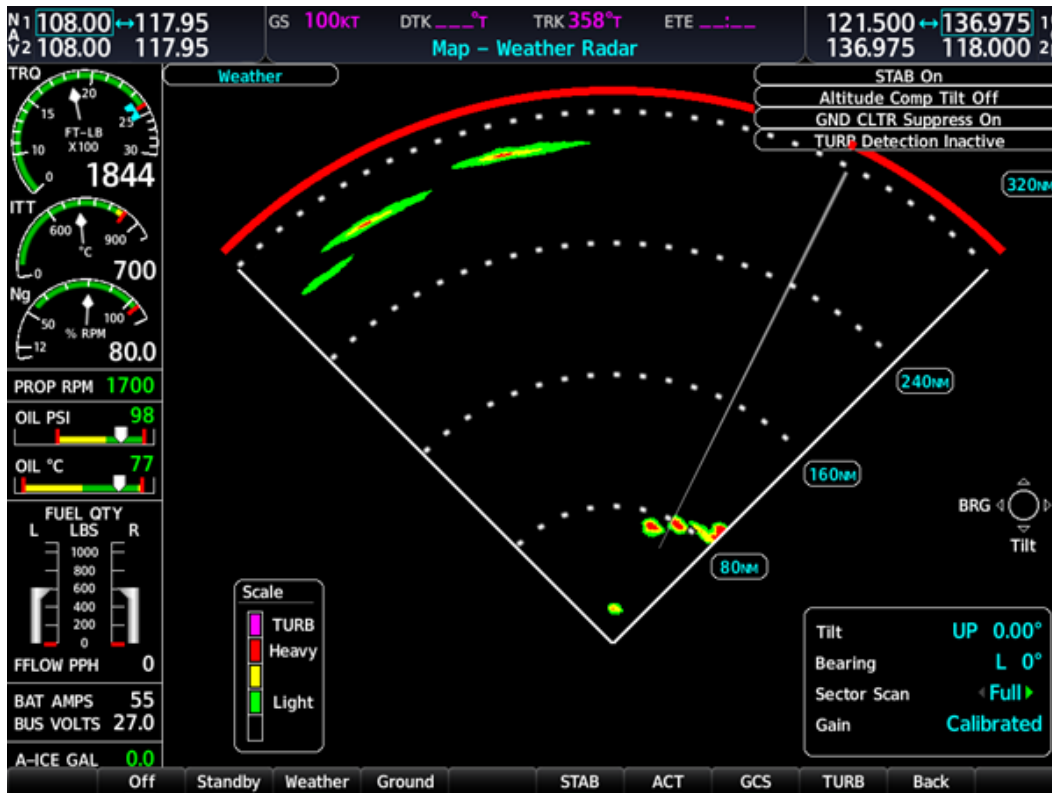
Figure 7-13. Weather Radar Screen

Perform an operational check by pressing each softkey on the Map-Weather Radar Screen (MFD-normal mode) for the proper operation of each function (see [Figure 7-13](#)). Ensure no abnormal or non-working annunciations or messages are displayed on the MFD Weather Radar Screen when testing each softkey. Refer to the Kodiak Pilot's Guide for a complete description of the GWX features and operation using the softkeys.

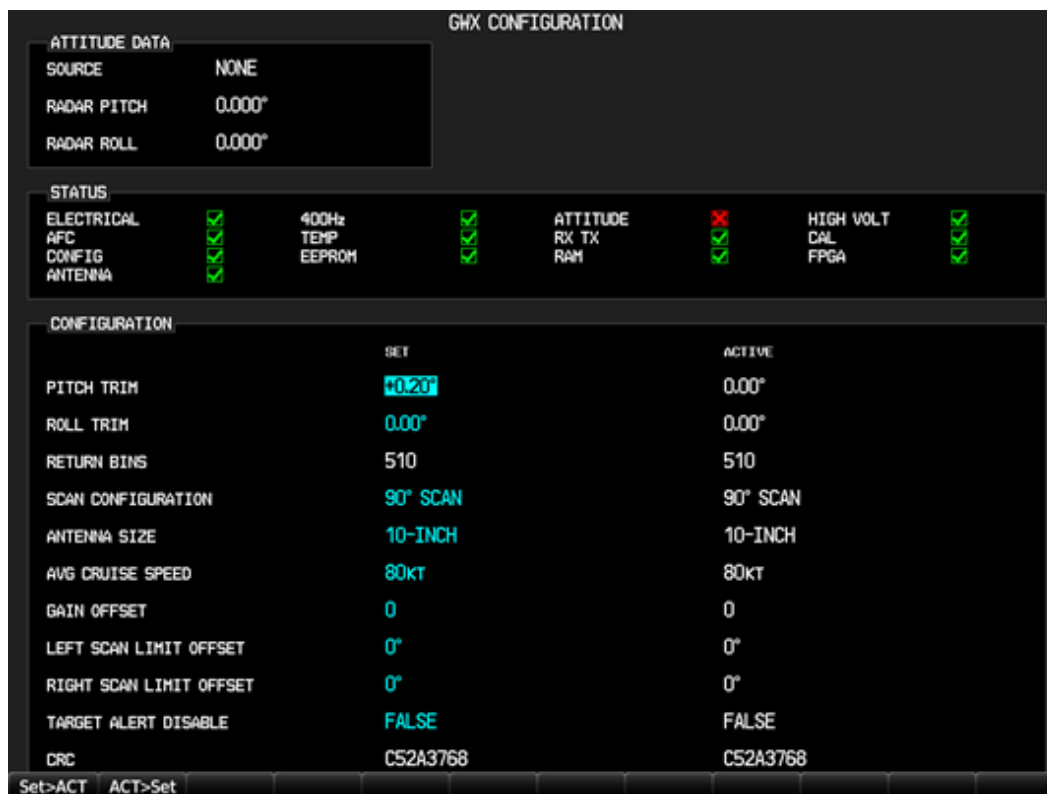
Figure 7-14. GWX Configuration Page

1. Select the GWX configuration page.

2. Press the FMS knob. The Pitch Trim field is highlighted.
3. Turn the small FMS knob and select the desired Pitch Trim value. The value must be between minus 4.00 and plus 4.00.
4. Press ENT. The GWX is configured to the new settings.

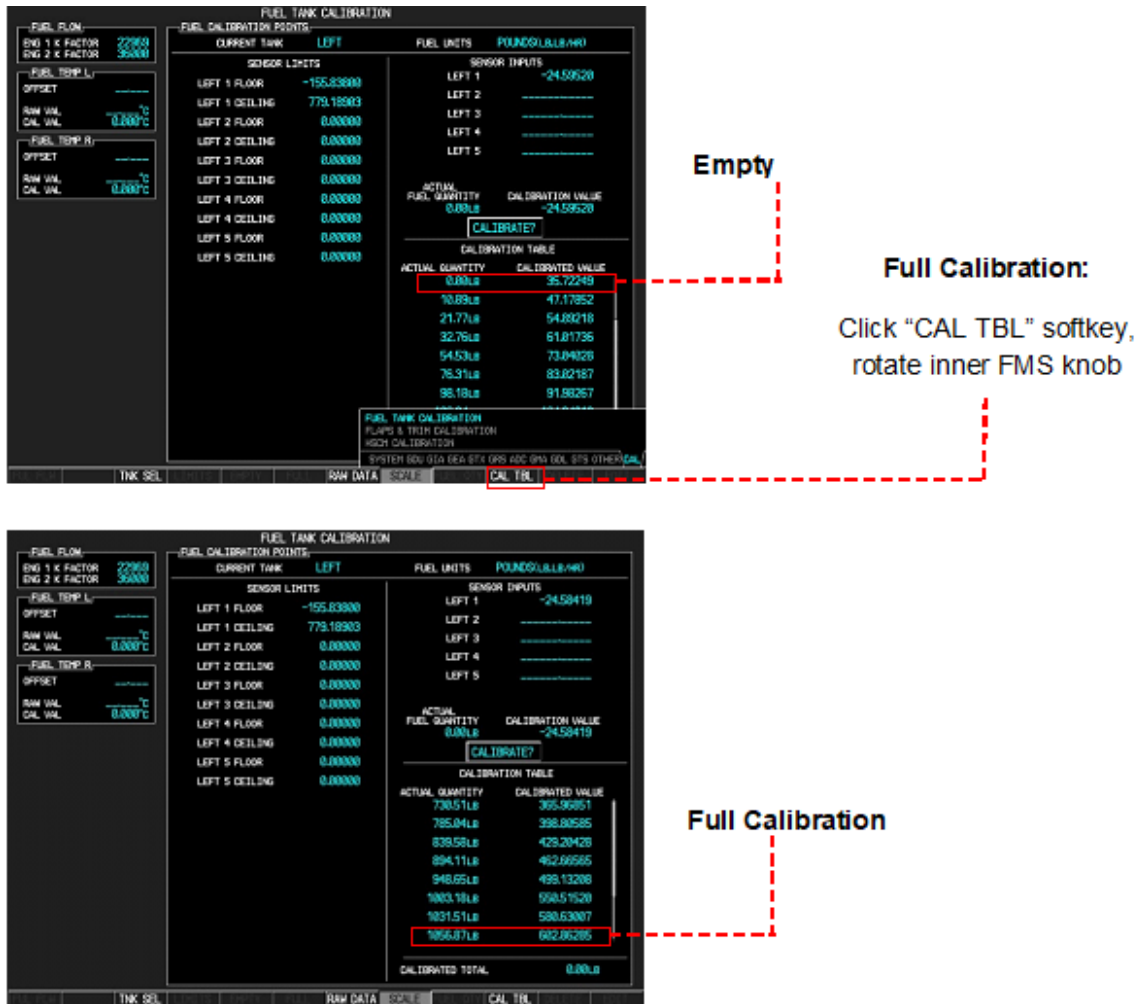
Figure 7-19. G1000NXi Fuel Calibration

Both Empty Calibration and Full Calibration must be performed on every aircraft. For the following instructions, refer to [Figure 7-19](#) for details on the G1000NXi Fuel Calibration page.

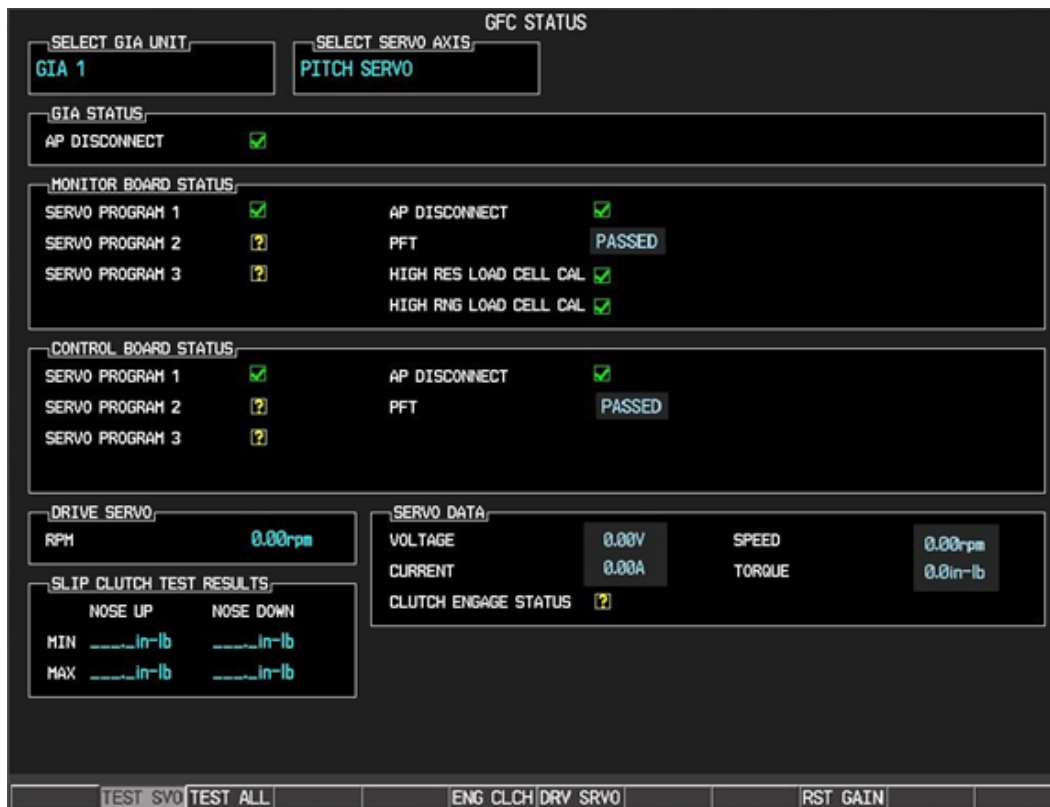
Figure 8-1. GFC Status Page

Start the G1000 NXi in Configuration Mode and select the GFC STATUS Configuration Page. Perform the following checks:
