## ***FIL.2017-T4 Rev. 1***

### **OPERATING IN ICING CONDITIONS**

October 2025

This updated Flight Information Letter (FIL) provides guidelines related to operations in icing conditions for TBM and Kodiak airplanes. It cancels and supersedes FIL.2017-T4, published in January 2017.

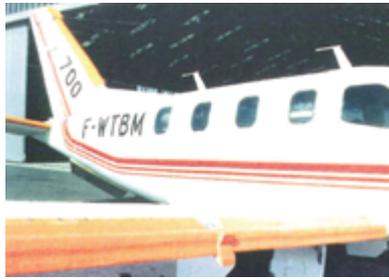
In 2011, Daher performed additional tests and analysis in response to an FAA aviation industry request concerning aircraft susceptibility to Ice Contaminated Tailplane Stall (ICTS) - referring to events that involve flow separation from the horizontal stabilizer due to ice accretion. Testing confirmed that the TBM demonstrated no susceptibility to ICTS in any flap configurations, or with aerodynamic surface contamination (natural ice and artificial ice shapes).

*TBM 700 with artificial ice shapes*

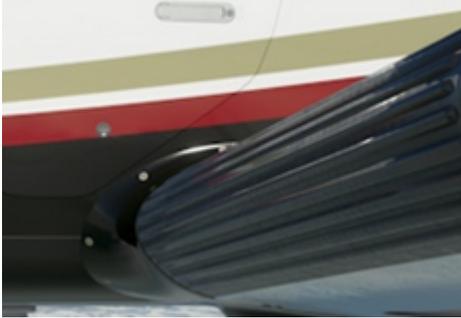
*Pneumatic deicing on the TBM*

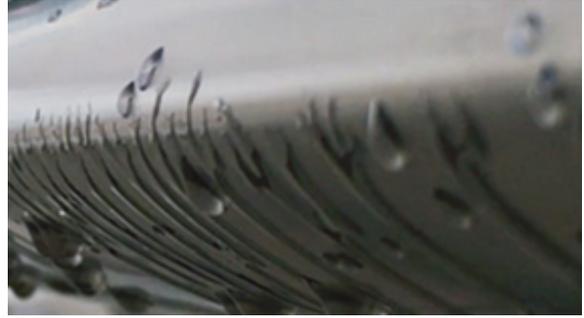
- The Kodiak 100 and Kodiak 900 are certified for FIKI - both when equipped with the optional TKS© ice protection system. During tests, the Kodiak was found to have susceptibility to ICTS in the full-flap (35°) configuration at normal approach speeds and with aerodynamic surfaces contaminated by ice. Therefore, both the Kodiak 100 and Kodiak 900 versions are limited to a maximum of 20° flaps for landing with ice suspected on the airframe, or when operating in icing conditions.

*TKS© fluid on the Kodiak*

- Because the Kodiak 100 and Kodiak 900 use a fluid-based ice protection system, there also are maximum speed limits which must be observed to ensure the effectiveness of the TKS© ice protection system in flight.

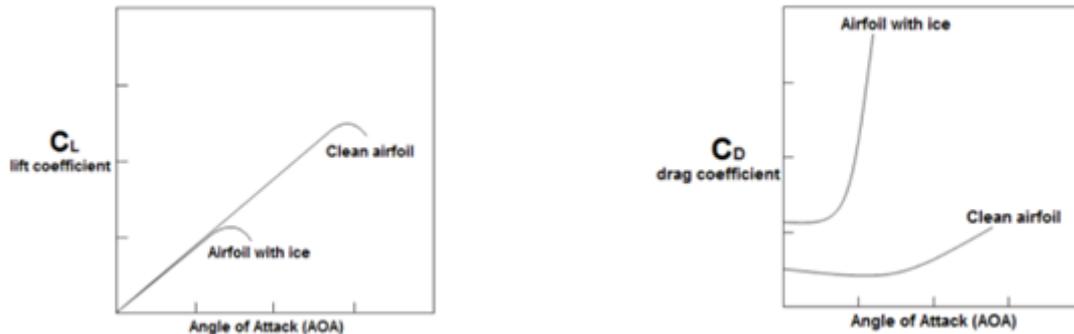
Aerodynamic performance and flight characteristics can be impacted when an aircraft is contaminated with ice. Ice accretion translates into a stall speed increase, as well as an increase in the weight of the aircraft.

There is a reduction in the max lift coefficient (ice-induced reduction in the critical angle of attack) and a drag increase due to ice accretion.

*AC 91-74B Pilot Guide: Flight in icing conditions*
