MANDATORY SERVICE BULLETIN

NUMBER: SB-020
REVISION: A
DATE: 10/16/2009

SUBJECT: FUSELAGE; MISSING FASTENERS

FUSELAGE; Missing Fasteners

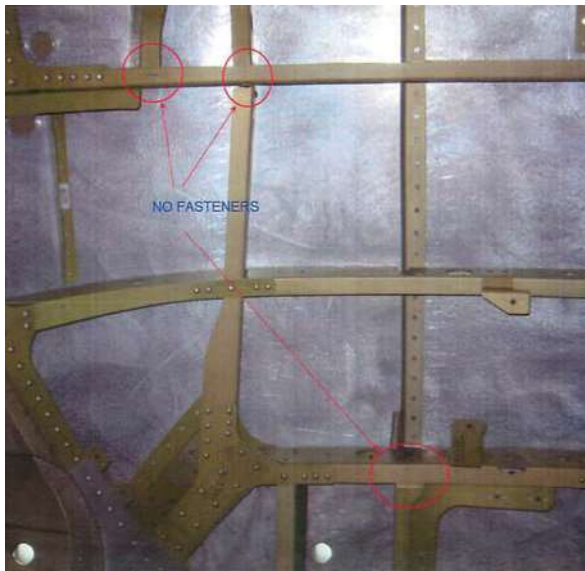
Figure 1: No Fasteners

Quest is mandating a one-time inspection of the ceiling in the forward cabin. The inspection is to identify whether 6 fasteners are present in the forward cabin. If the fasteners are present, no action is needed. If the fasteners are not present, the fasteners will need to be installed following the directions contained in this Service Notification.

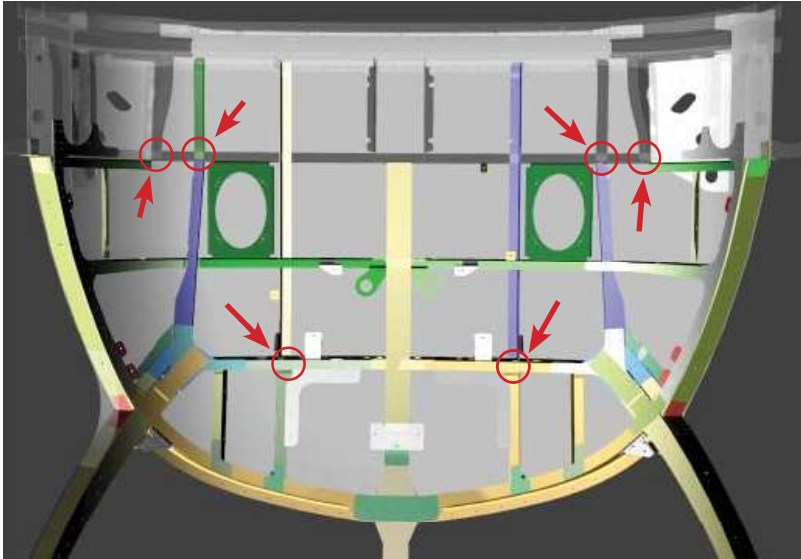
Task	Instruction
1	Remove the PSU ducts, and the forward Center Ceiling Panels (2) over the crew doors, in accordance with the KODIAK Maintenance Manual.
2	<p data-bbox="180 926 636 974">Locate the areas in the cabin ceiling indicated in Figure 1.</p> <p data-bbox="706 512 789 533">Figure 1</p>

Task	Instruction
<p>4</p>	<p>Install fasteners (P/N CR3213-5) in the four AFT locations and fasteners (P/N CR3213-4) in the two FWD locations indicated in Figure 1. For fasteners (P/N CR3213-5) hole diameter must be dimensioned at 0.159 - 0.164 with a minimum edge distance of .300. For fasteners (P/N CR3213-4) hole diameter must be dimensioned at 0.129 - 0.134 with a minimum edge distance of .250. Figure 4 and Figure 5 illustrate the completed installation.</p> <p>Note: Fasteners shown in Figure 5 are Solid Rivets.</p> <div data-bbox="711 199 1469 940"> <p>Fastener (P/N CR3213-4)</p> <p>Figure 4</p> <p>Will be Fasteners (P/N CR3213-5)</p> <p>Figure 5</p> </div>

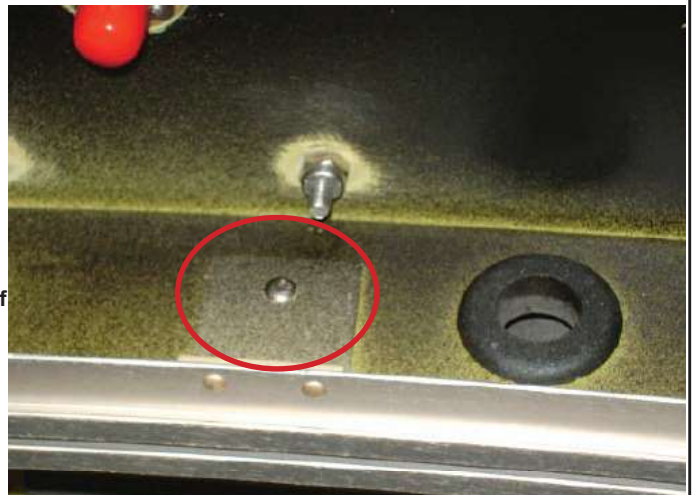
Figure 2

Remove fasteners in clips that hold the curtain track, as needed, to gain access to locations indicated in **Figure 2**.

NOTE: To eliminate the possibility of damage and for ease of clean up of the buck tails, remove the speakers.
